REVETTING AND SUPPORTING RIVER BANKS

4.5 Supporting bank slips and exposed tree roots

River Skerne

LOCATION – Darlington, Co Durham, NZ 301160

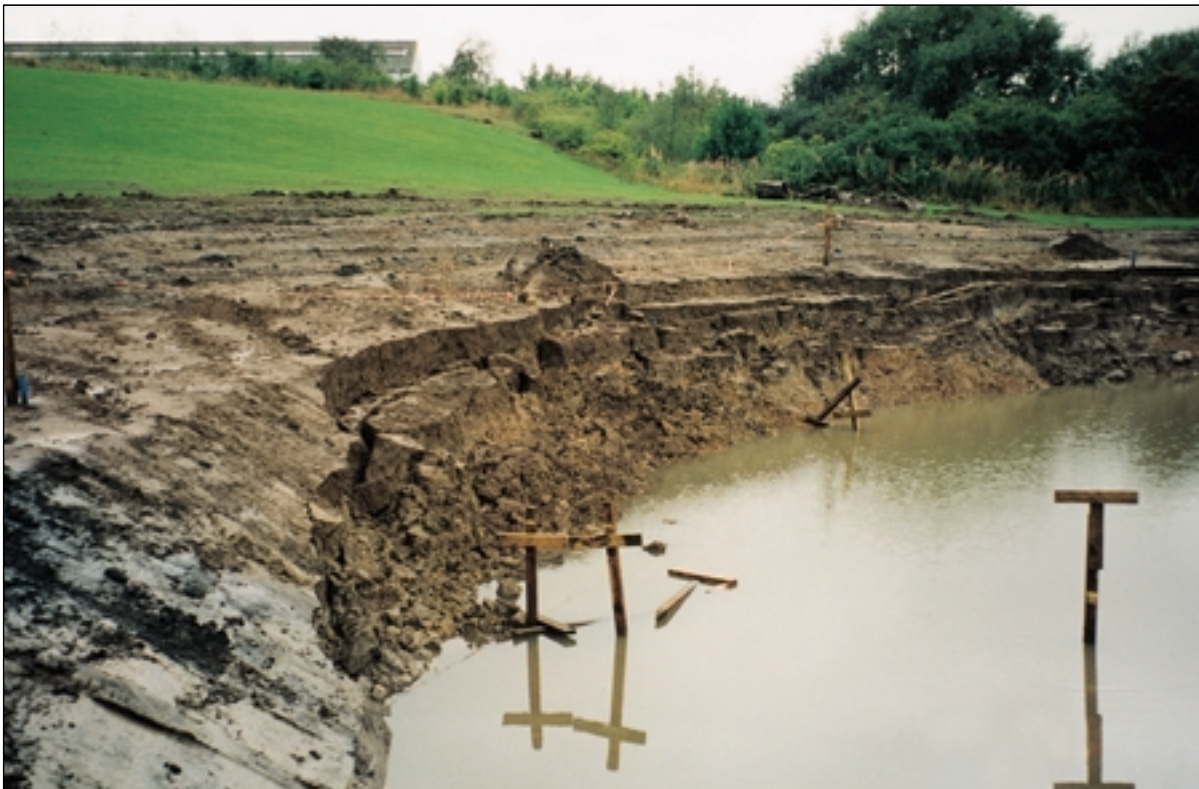
Slipped slope during work – September 1995

During works, water seepage from gravel at the bottom of a newly excavated river bank caused it to slip. As the bank was close to banded industrial fill, repair was necessary. The route of a proposed footpath was also at risk if this bank remained unstable.

To stabilise this slope it was reformed incorporating a rock layer using stone sized 300mm 'down' as specified for use on nearby revetments (see 4.2). Ledges of varying widths were introduced at metre intervals up the slope, above water.

The underwater rock layer added weight to the toe of the slope to help support it and was free draining. The upper bank re-profiling removed weight from the slope further stabilising it. The ledge closest to water level was subsequently planted with trees to add visual amenity as well as a longer term revetment via their root system. The upper ledge later incorporated a new footpath.

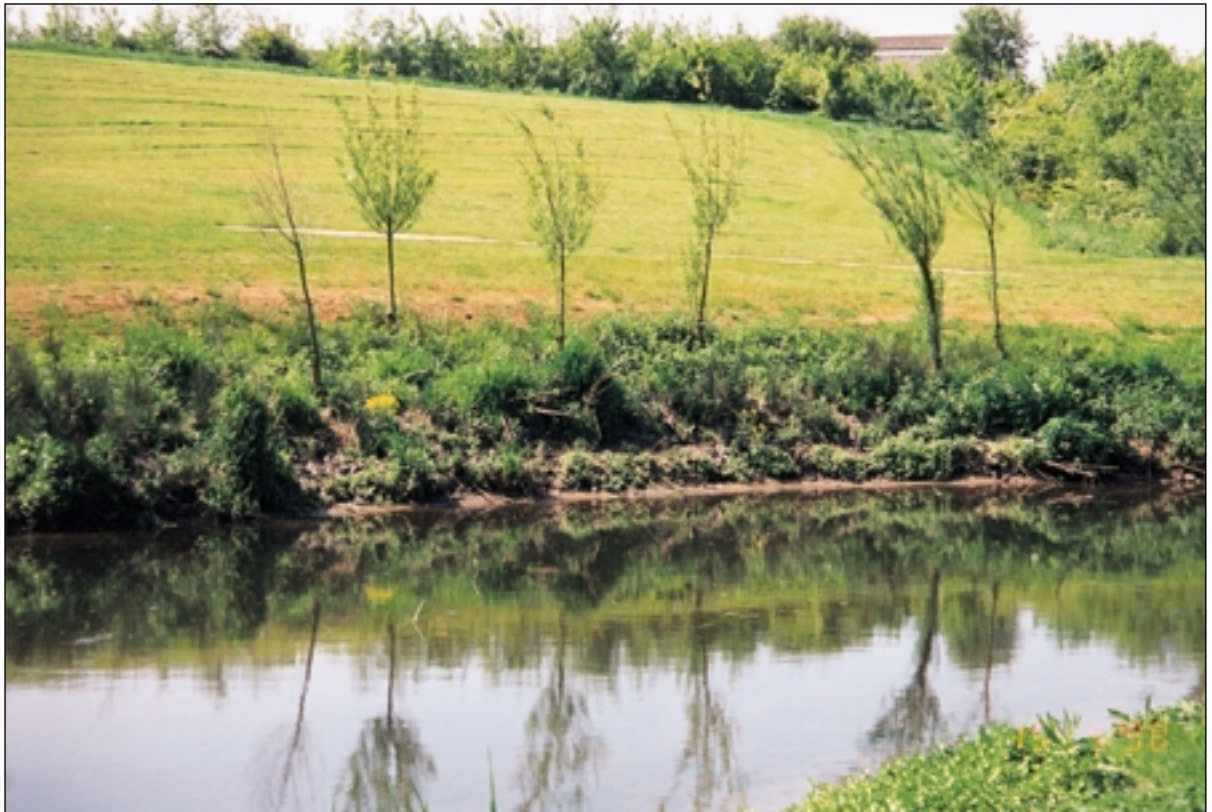
Slipped slope 2 years after repair – 1997

The bank slip has remained stable and appears natural with no visible signs of support. Water continues to seep from the bank and maintains a small wetland habitat on the ledge above river level.

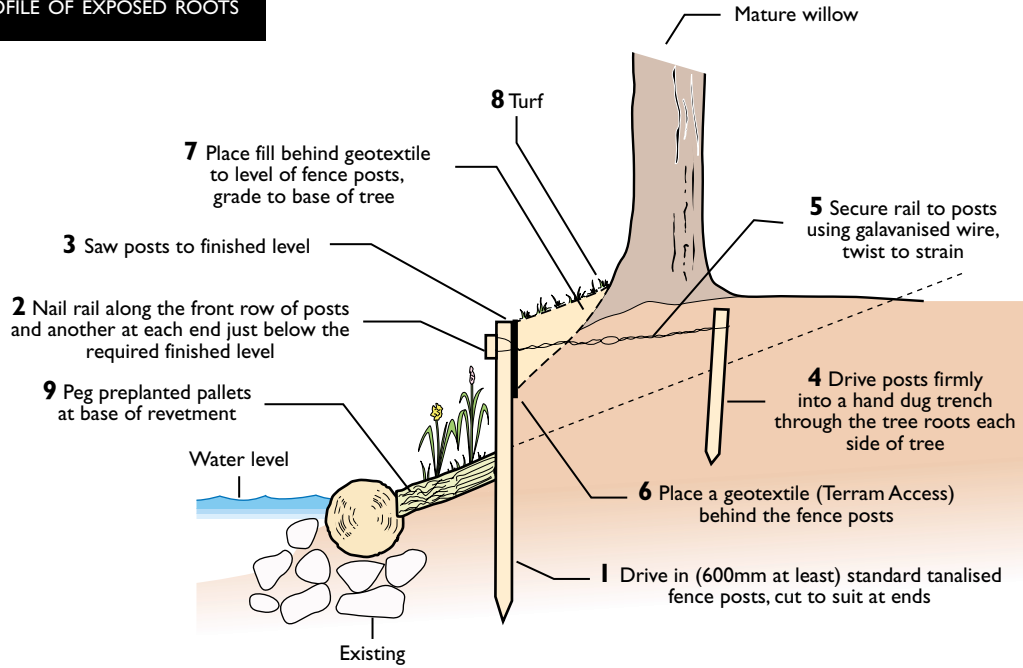
Figure 4.5.2
PROFILE OF EXPOSED ROOTS

The roots of a mature willow had been exposed during river bank re-profiling works and were being undermined by high flows and damaged by people. Although in no immediate danger, this tree had become an important resting place, providing the only shade along this bank. Positioned on the apex of a meander, it was decided to protect the roots using a simple revetment.

The design had to ensure that people could continue to use the spot without further damage. Vertical fence posts were used torevet the bank before back-filling with soil. A geotextile, ‘Terram Access’, was placed behind the posts to prevent soil migration. Turf was placed on the surface to achieve an instant result.

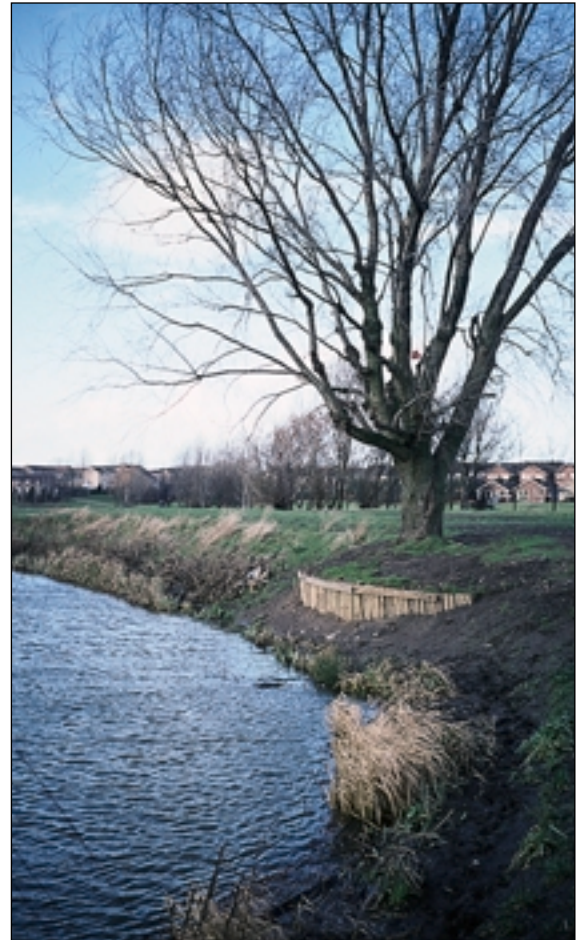
The revetment of the exposed roots has performed well, following many high flows since its construction. The roots are no longer exposed and the turf and other planting has grown to give added protection. Well used by a variety of people, the structure has become a seating area providing shade.

Protected roots after work completed – February 1997
