The Ogwen is in a mountainous location of Snowdonia below Llyn Ogwen (Lake Ogwen), alongside the A5 trunk road. Water from Llyn Ogwen cascades over Rhaeadr Ogwen (Ogwen Falls) down into the large glacial valley of Nant Ffrancon through which the Ogwen flows northwards. During the 1960's the Ogwen was deepened by dredging over a 4km length downstream of the waterfall. This was to reduce the frequency of flooding over the valley floor to improve livestock grazing. The dredging of the river proved to be difficult in places where substantial deposits of boulders were present. Rock outcrops were blasted at the lower limit of works at Pont Ceunant. Most dredgings were piled along the river banks forming irregular embankments, some were removed from site.

Controlling River Bed Levels, Water Levels and Flows

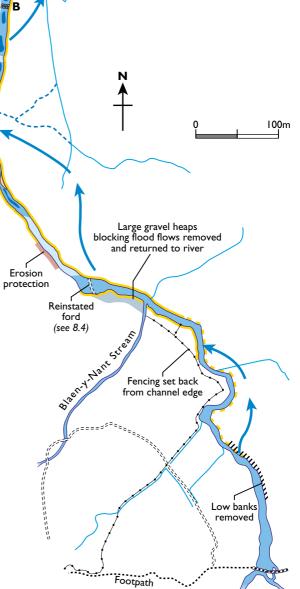
Deep channel and dredgings on bank at Blaen-y-Nant confluence

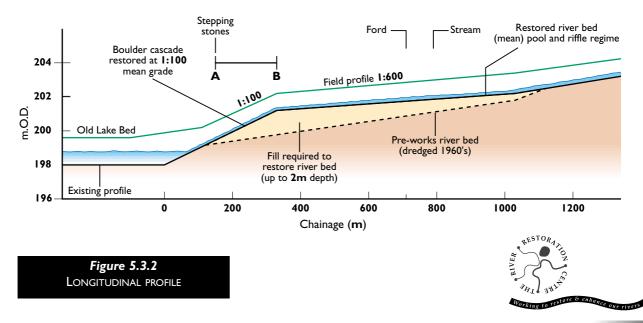
Restored bed levels and bank profile

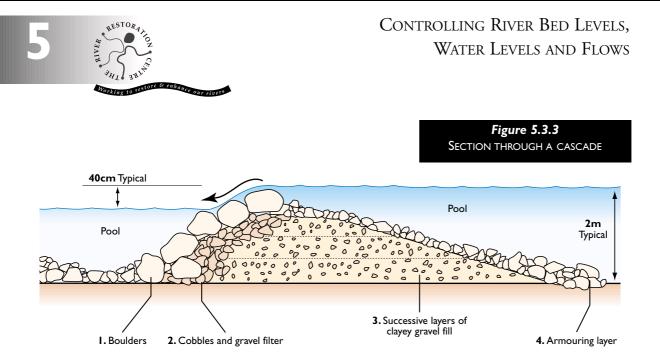
Lower 'stepping stone' cascade

The lower cascade was the smallest of the four so was readily adapted to restore a series of large stepping stones recorded on O.S. maps. The effect of restoring the cascade was to impound the upstream reach of river to a water depth of 2m. Ideally this upper reach would have been completely backfilled to the 1 in 600 gradient shown on figure 5.3.2. but insufficient material was available for this because dredged gravels had been removed from site.

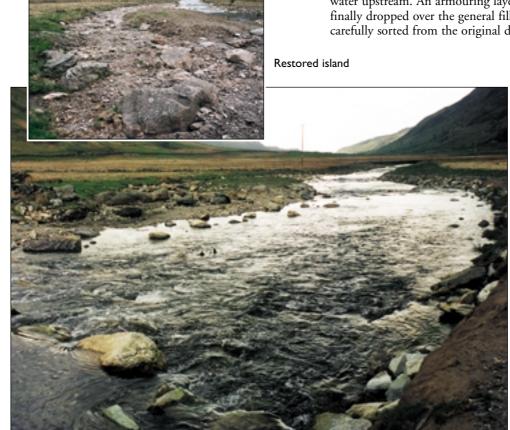
Restoration of boulder cascade, stepping stones and braided channel
