# RESTORING MEANDERS TO STRAIGHTENED RIVERS

## 1.1 New meandering channel through open fields

### RIVER COLE

LOCATION - Coleshill, (Oxon/Wilts border) SU 234935

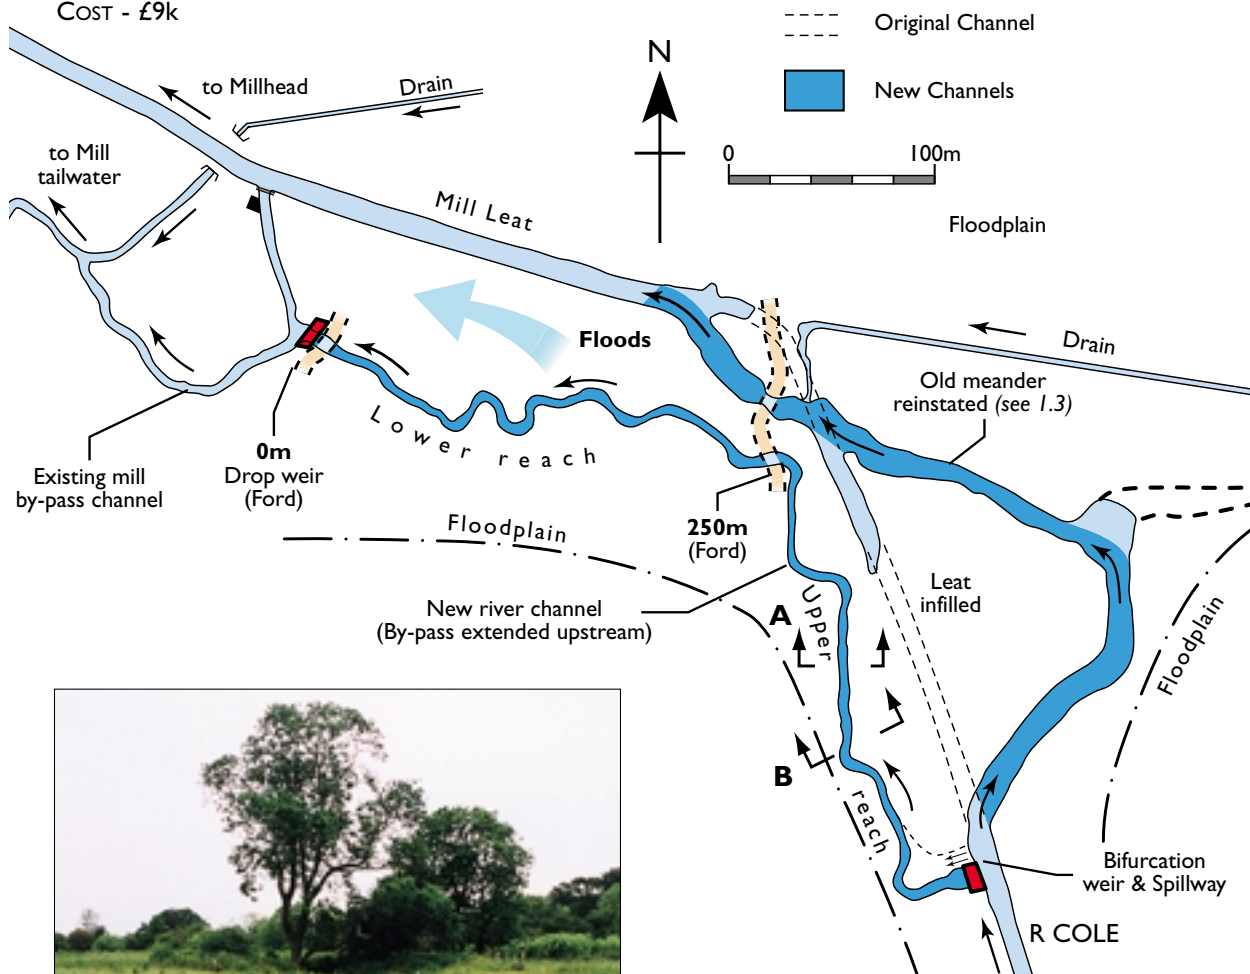
**Figure 1.1.1**  
PLAN OF UPSTREAM OF MILL

*Alignment of channel (fig. 1.1.1)*

The existing mill by-pass follows an ancient course of the River Cole. Remnants of its ancient course were

also evident in the fields between chainage zero and 250m, (lower reach), so the new channel was set to follow these at a fairly uniform depth of c. 1m. Upstream of ch. 250m the new channel deviates from any natural course because it had to be aligned roughly parallel to the mill leat which is unnaturally close to the edge of the floodplain. Land levels along this upper reach rise significantly above the average for the floodplain, hence the new channel is deeper. Meanders were set out to 'mimic' the natural form evident in the lower reach.

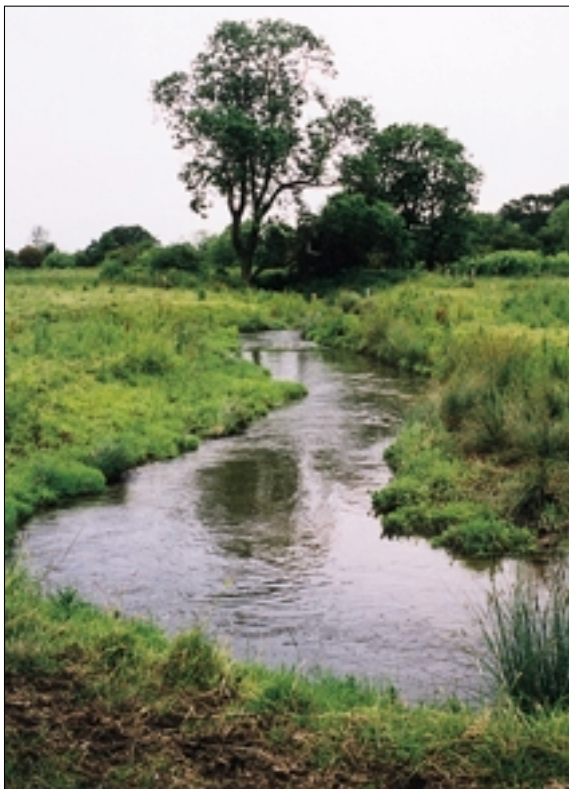
Lower reach in Summer - August 1997

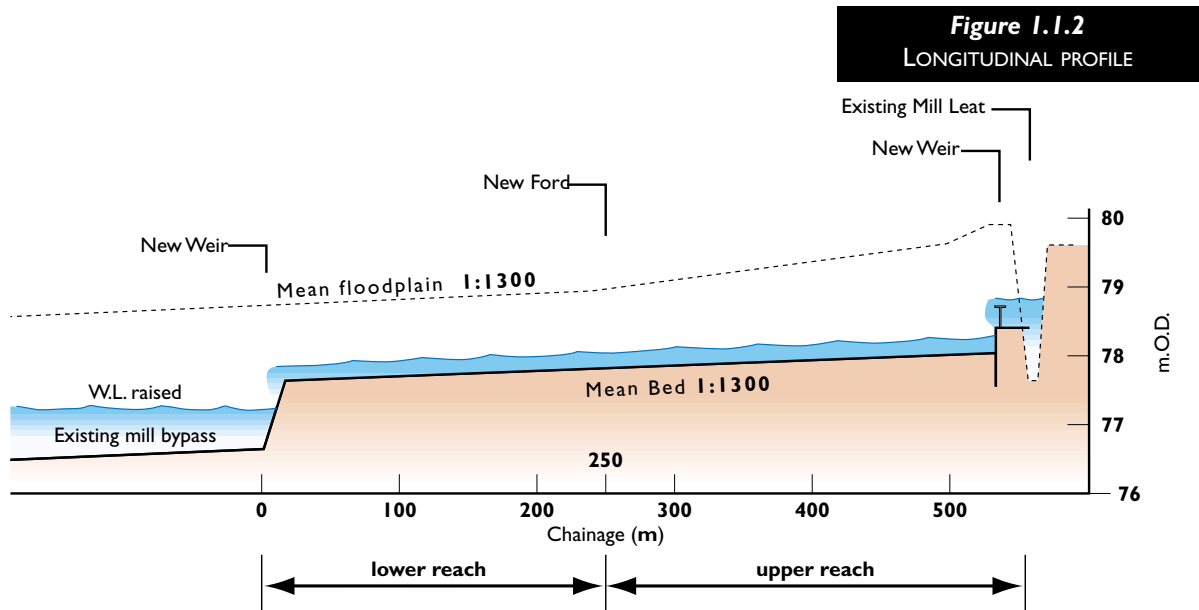
*Longitudinal profile (fig. 1.1.2)*

The new mean bed gradient was set at 1:1300 to match the mean floodplain gradient. The bed elevation was set to give the shallowest channel

possible whilst having just sufficient depth to contain summer spates. The resultant channel bed is elevated higher than the old mill by-pass, but is lower than the retained water level in the mill leat which feeds it. Drop weirs were therefore required at each end (see 5.1 and 5.2).

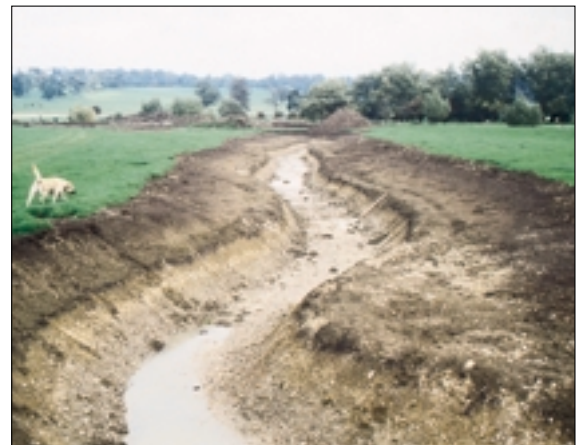
Upper reach at time of excavation – October 1995

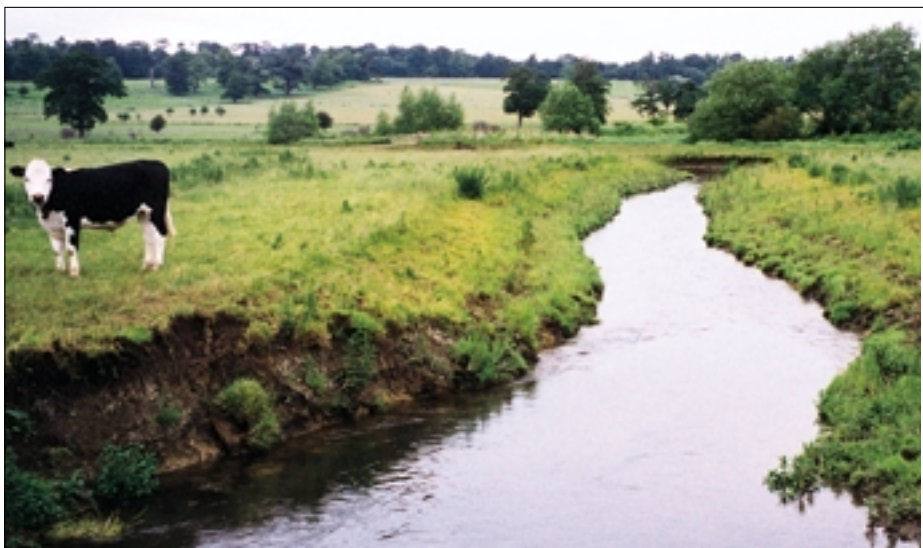
Upper reach – 1998

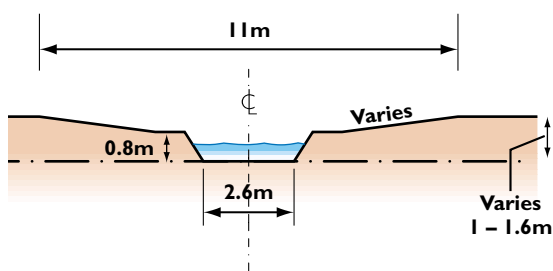
**Figure 1.1.3**

Section A shows a normal flow channel 2.6m wide by 0.8m deep - the geomorphology of the Cole indicates this to be the ideal size of channel. Because overall channel depth needed to exceed 0.8m

(fig. 1.1.2). The upper banks were graded back as flat as practical.

**SECTION A THROUGH SYMMETRICAL CHANNEL**

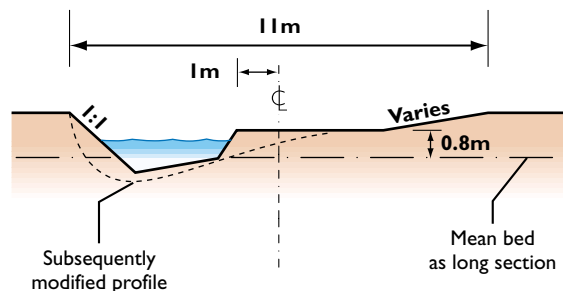
**Figure 1.1.4**

Section B shows a compatible asymmetrical profile introduced at each significant bend. The deepest bed level is cut below the mean bed gradient to introduce pools. The 1:1 batters on the outside of the bend were expected to steepen through natural channel adjustment.

Land levels were lowered to a depth of 0.8m above mean bed as shown on Section B. As all meanders are small in amplitude, no further shaping was undertaken; profiles were simply rounded off to give smooth transitions into Section A either side. The profile was later modified (*see below*).

**SECTION B THROUGH ASYMMETRICAL CHANNEL**

The stiff clays in the river banks resisted erosion preventing cliffs from forming on the outside of meander bends where 1:1 batters were cut. Conversely, floodwaters were racing across the flat areas formed on the inside of each meander causing scour of the surfaces. The asymmetrical profiles were subsequently re-excavated as indicated on Section B.

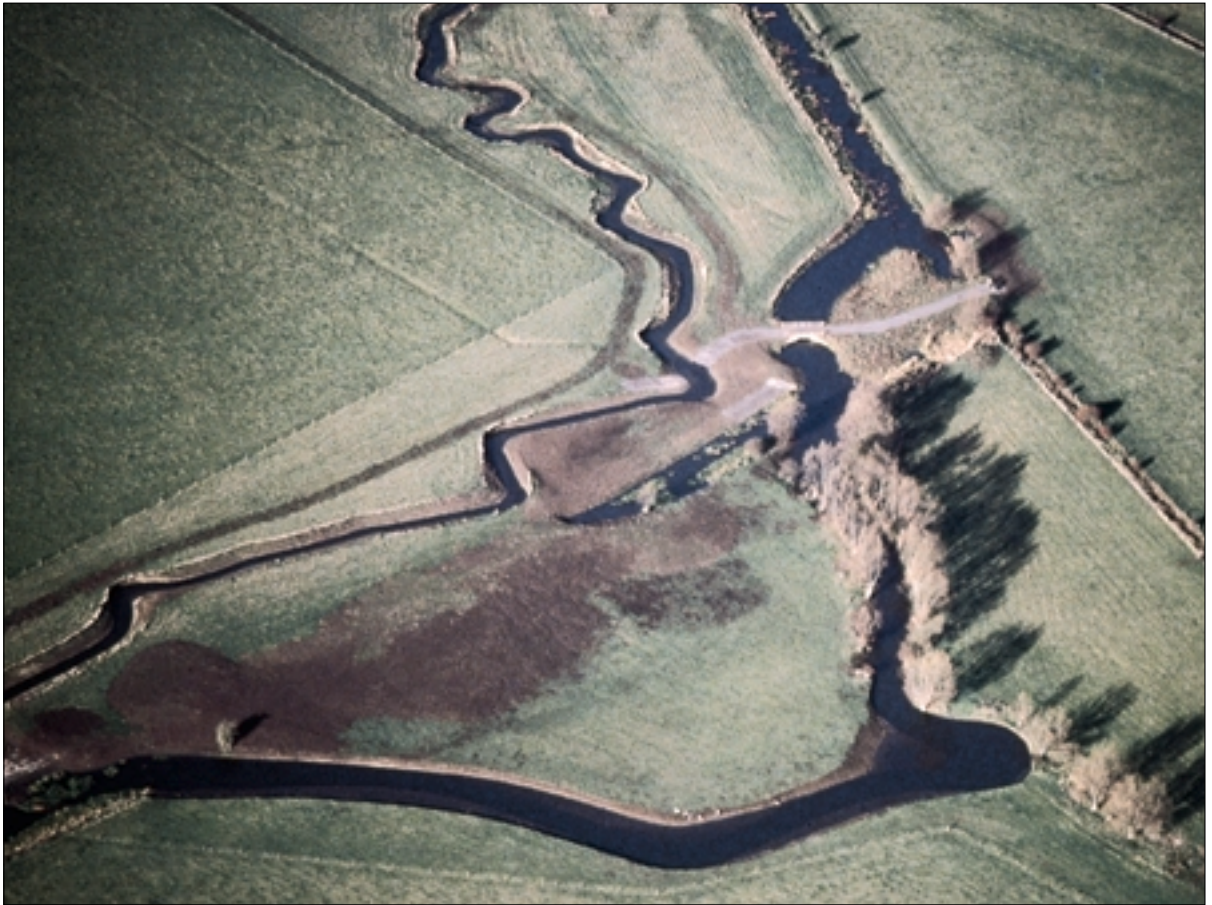
The new meandering river course and the restored meander in the mill leat (see 1.3) – July 1997  
Photo: Environment Agency
