ENHANCING STRAIGHTENED RIVER CHANNELS

3.7 Replacing a concrete drain with a 'natural' channel

YARDLEY BROOK

LOCATION - Shard End, South-east Birmingham SP 118198

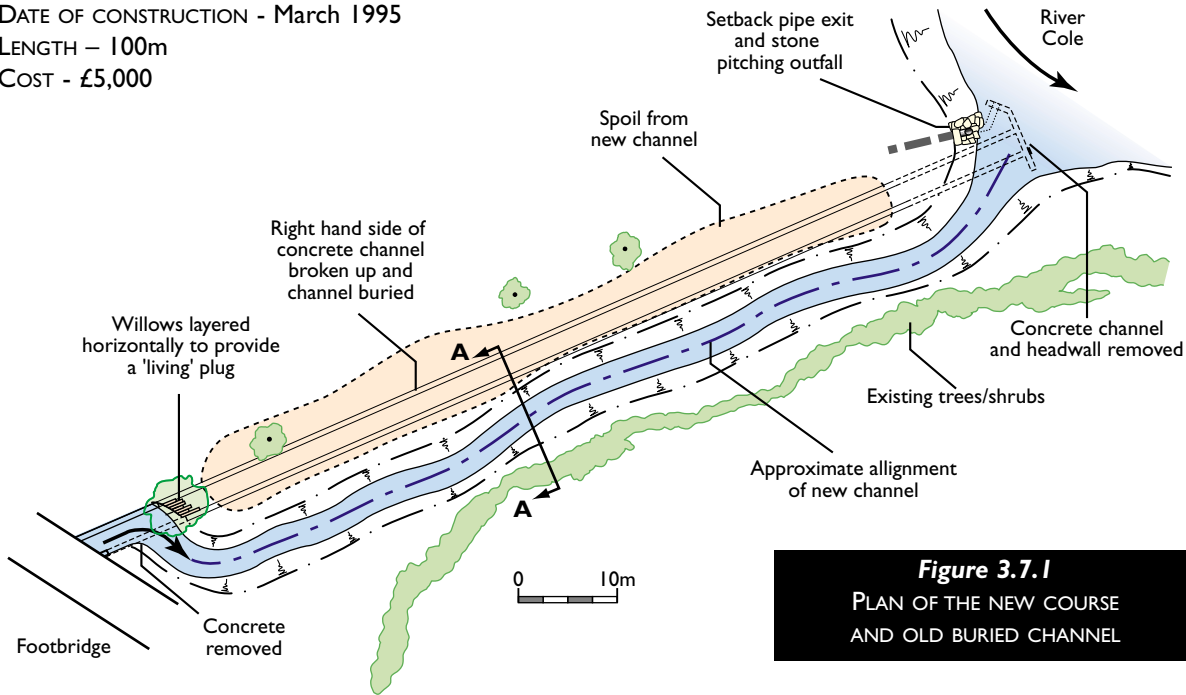
Figure 3.7.1
PLAN OF THE NEW COURSE AND OLD BURIED CHANNEL

Figure 3.7.1 shows the 100m sinuous channel that was excavated alongside the brook. The new course was excavated at a greater depth than the concrete channel bed. Previously the bed of the River Cole had been approx. 700mm below the concrete outfall, as a result of deepening of the Cole over the lifetime of the concrete brook. A simple 'V' shaped channel was dug with sloping earth banks as it was decided that the brook could sufficiently shape itself. Over-specifying the design would not be cost-effective.

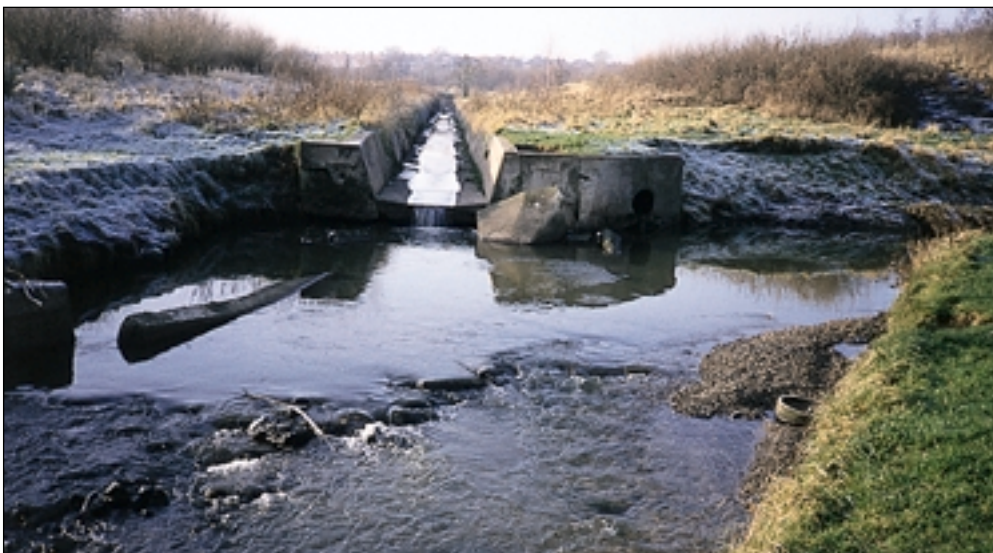
Yardley Brook – entering the River Cole. Before works

The brook was constrained in a concrete sleeve, offering no possibility for small-scale in-channel enhancement. Rehabilitation required removal of the brook from its 100m long concrete surround. Complete relocation, rather than removing the concrete, was the cheaper option.

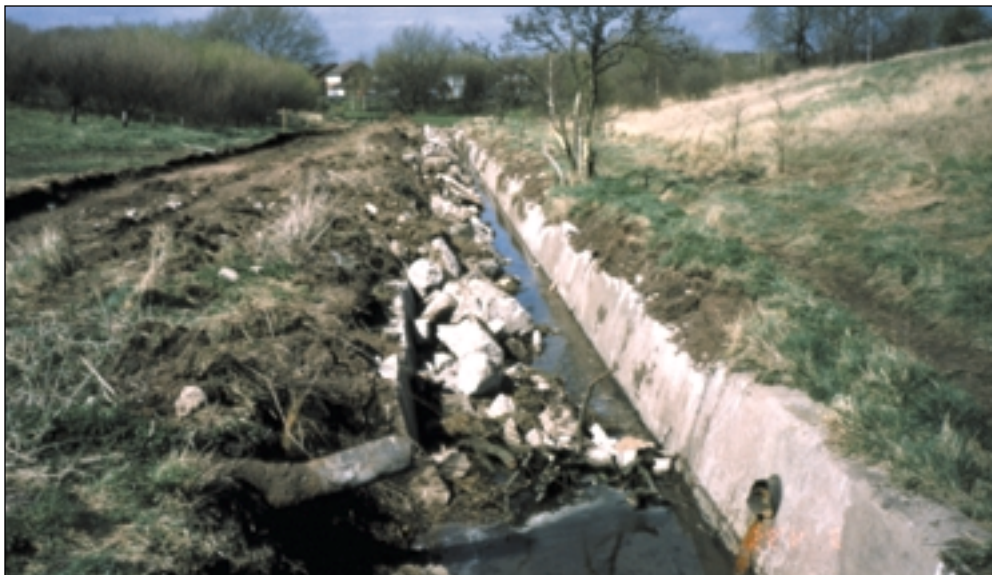
The lip of the concrete channel was broken up using an excavator, to ensure that once buried the remnant channel would not protrude above ground level. The broken concrete was pushed into the barely flowing channel.

Concrete channel being broken up

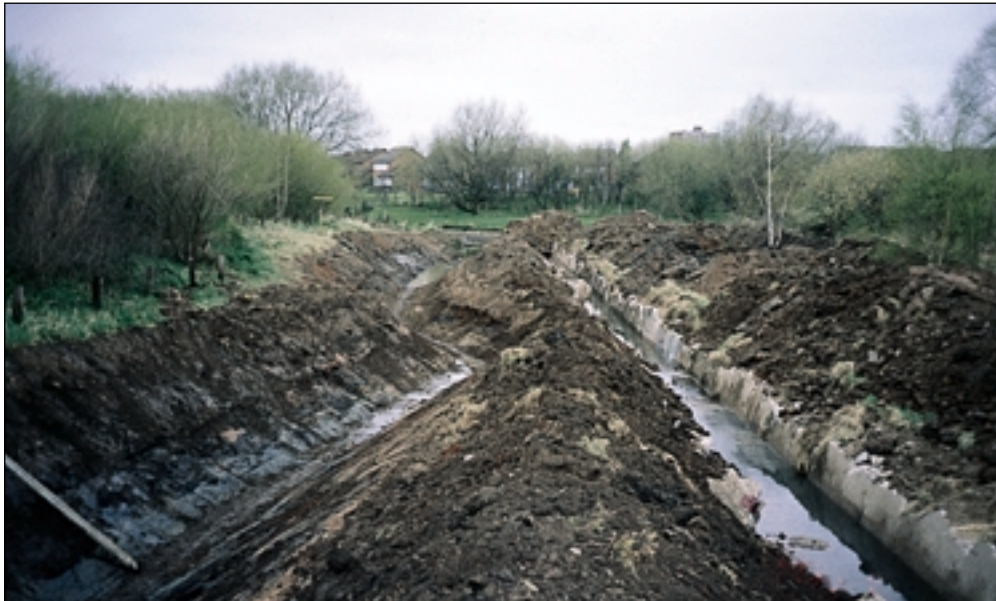
The 'new' Brook being excavated adjacent to the old channel. Spoil stockpiled

the opposite bank of the old channel. This maintained the flow through the old drain and allowed all work to be carried out in the dry. Once completed flow was diverted through the new course, and the old channel was filled using the spoil from the new.

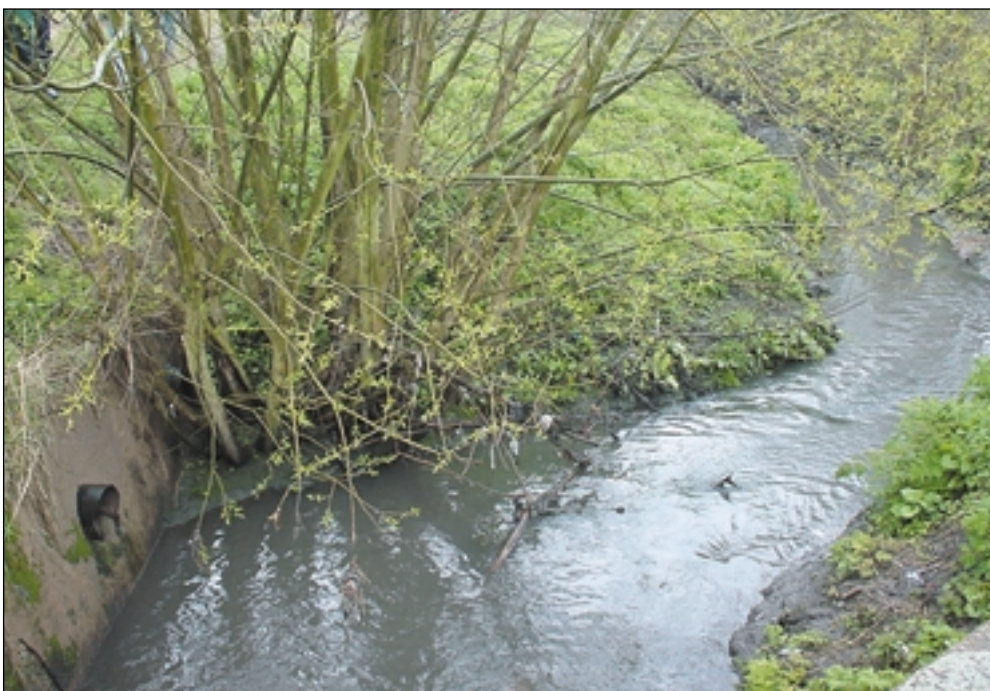
At the upstream end of the 'new' brook the old course was blocked with rubble then plugged with live willows laid in during the in-filling process to form a growing plug.

Live willow plug

The live willow plug has grown to secure the breakout point of the new brook. This area now blends in well with the general appearance of the brook and its self-set bankside trees and shrubs.

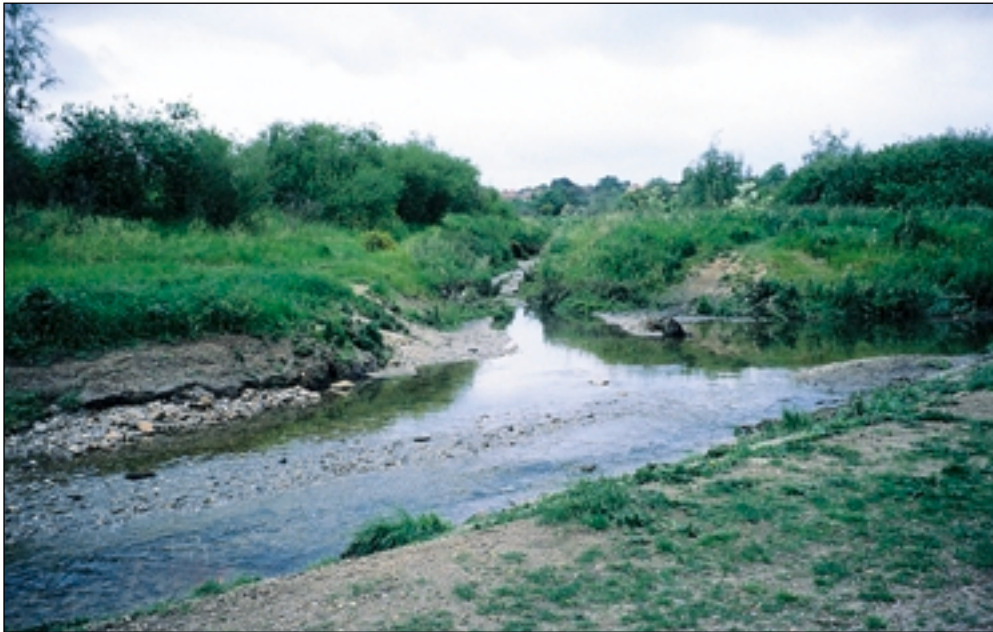
After:
The new
'natural' Brook

Immediately following the diversion to the new channel a dramatic change in the habitat quality of the brook was achieved in terms of landscape, visual amenity and ecology.

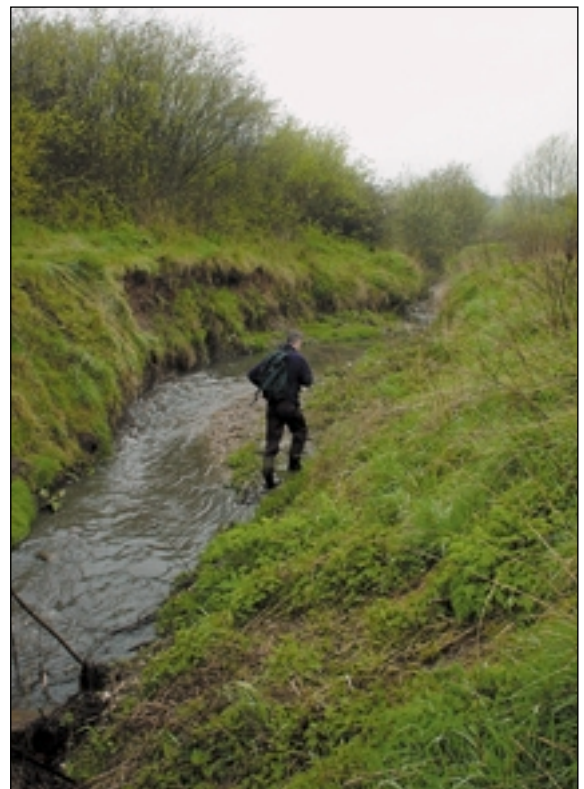
Six years on, Yardley Brook has developed 'natural' channel features in contrast to the concrete channel previously in place. The brook still suffers from periodic poor water quality due to the dense urban population that surrounds it.

Six years on:
Earth cliffs, gravel shoals and a diverse flow
regime. April 2001
