# ENHANCING STRAIGHTENED RIVER CHANNELS

## 3.8 Creation of on-line bays

### RIVER TALL

LOCATION - Address, nr. Moy, Co. Armagh, N. Ireland. OS Map 19, H916555

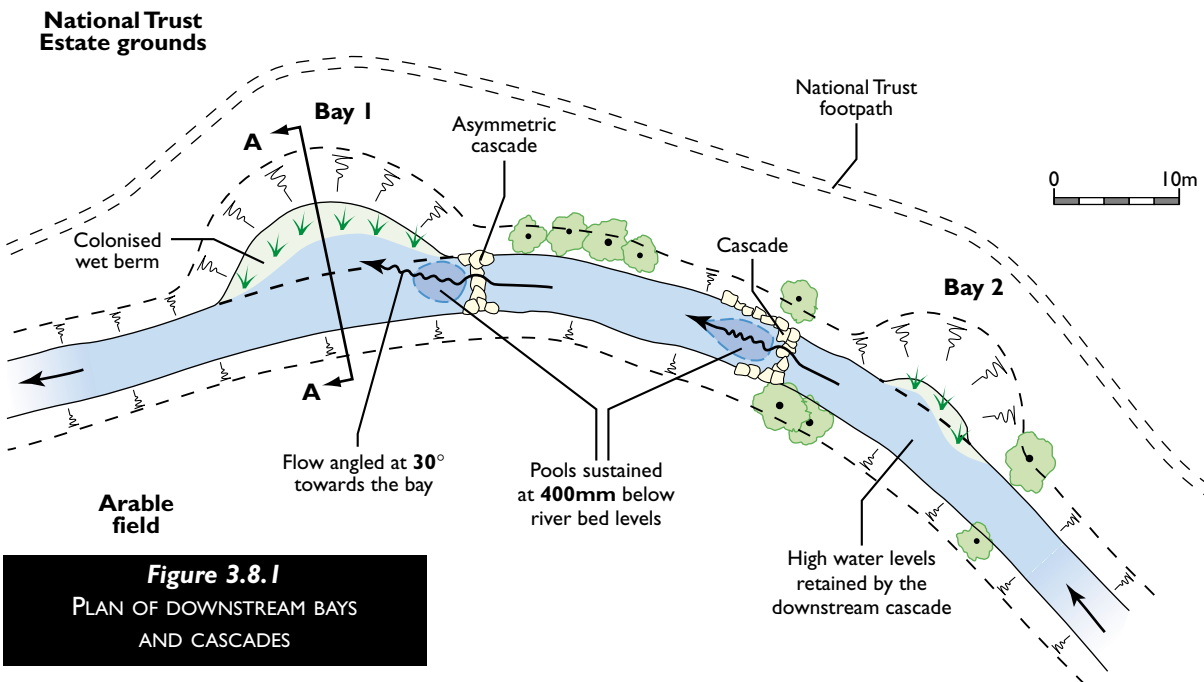
**Figure 3.8.1**  
PLAN OF DOWNSTREAM BAYS AND CASCADES

Bay 1 (*figure 3.8.1*) is similar in size to bay 4 but is able to retain its open nature due to the positioning of its cascade. The flow of water over the boulders is angled into the bay, approx. 30 degrees offset from the main channel. This directional flow is helping to maintain the bay at low and high flows.

Bay 2 (*figure 3.8.1*) rapidly silted up and colonised with emergent vegetation, spreading well into the main channel. The cascade for this bay was placed downstream, resulting in increased water levels from the backwater effect created. This has reduced flow velocity and now acts as a silt trap, promoting silt deposition and vegetation growth.

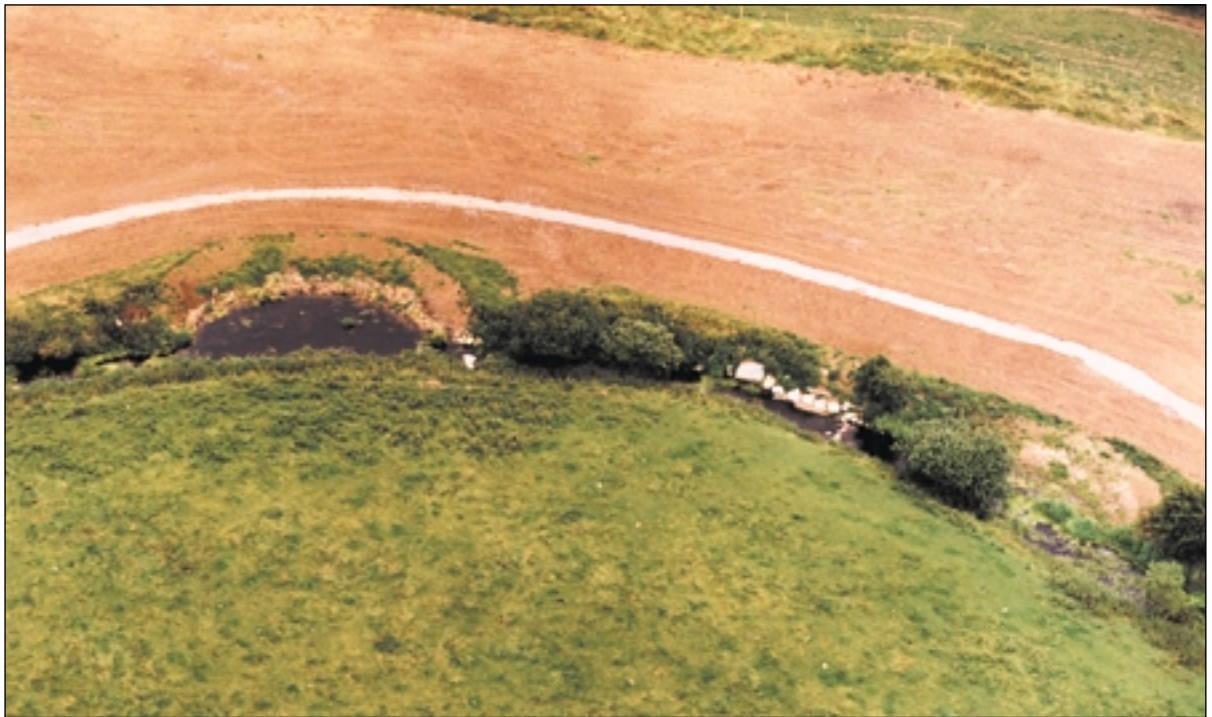
Downstream bays after less than a year.  
Note: Bay 2 is already becoming choked with vegetation

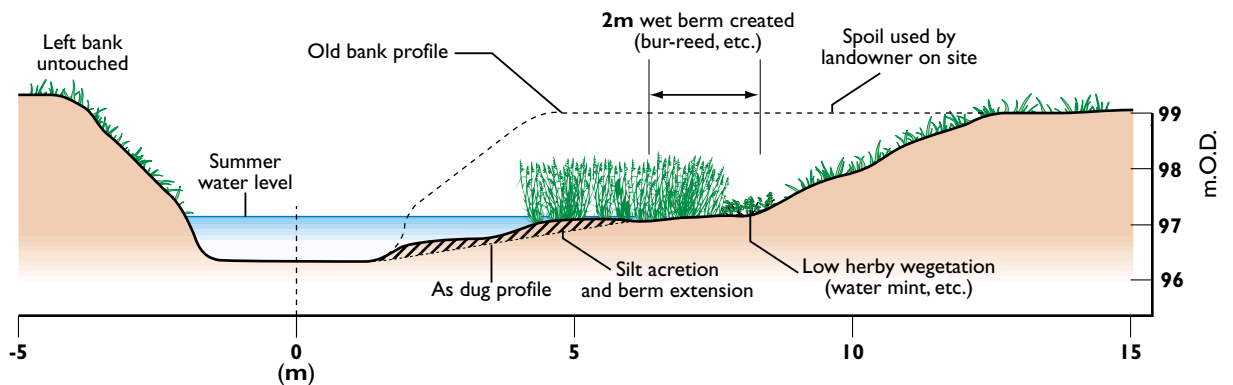
**Figure 3.8.2**  
SECTION A THROUGH BAY 1

From the ledge the bank rises at a batter shallower than the existing 1:1 bank (approx. 1:2 to 1:3). The batter angle varies with the difference between bed and bank top (from 2 to 4m) (figure 3.8.2).

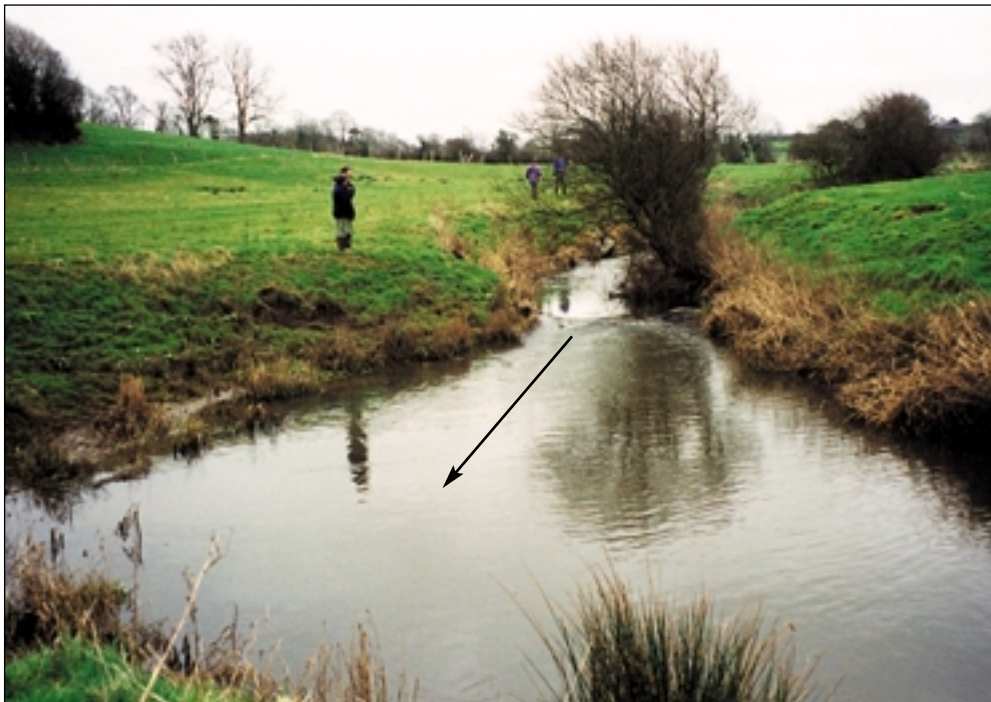
Bay 1 showing the angle of flow keeping the bay 'open'
