CONTROLLING RIVER BED LEVELS, WATER LEVELS AND FLOWS

5.2 Drop-weir structures

RIVER COLE

LOCATION – Coleshill, Oxon/Wilts border, SU 234935

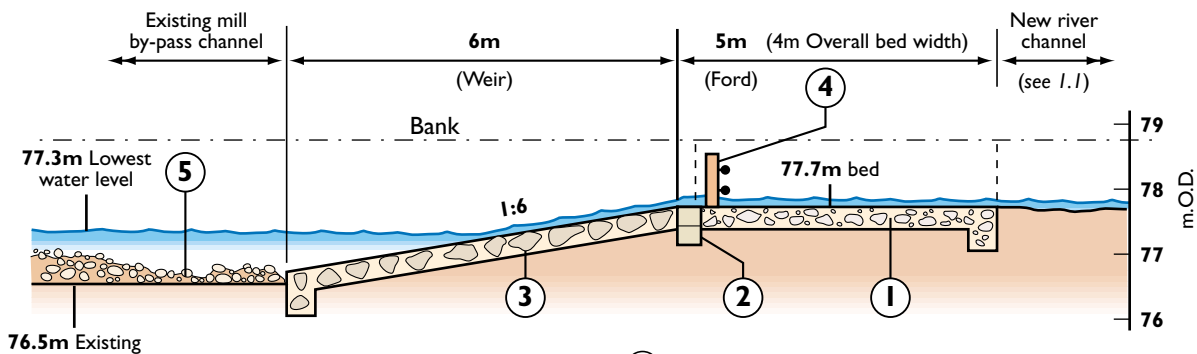
Figure 5.2.1
DROP-WEIR ON NEW RIVER UPSTREAM OF MILL

- ① Ford – 150mm down densely graded stone over polythene membrane
- ② Cut-off wall – concrete kerb blocks (incorporates membrane)
- ③ Weir – 300mm down densely graded stone over filter membrane
- ④ Stock fence comprising two strained cables
- ⑤ Gravels deposited over existing bed of old mill by-pass

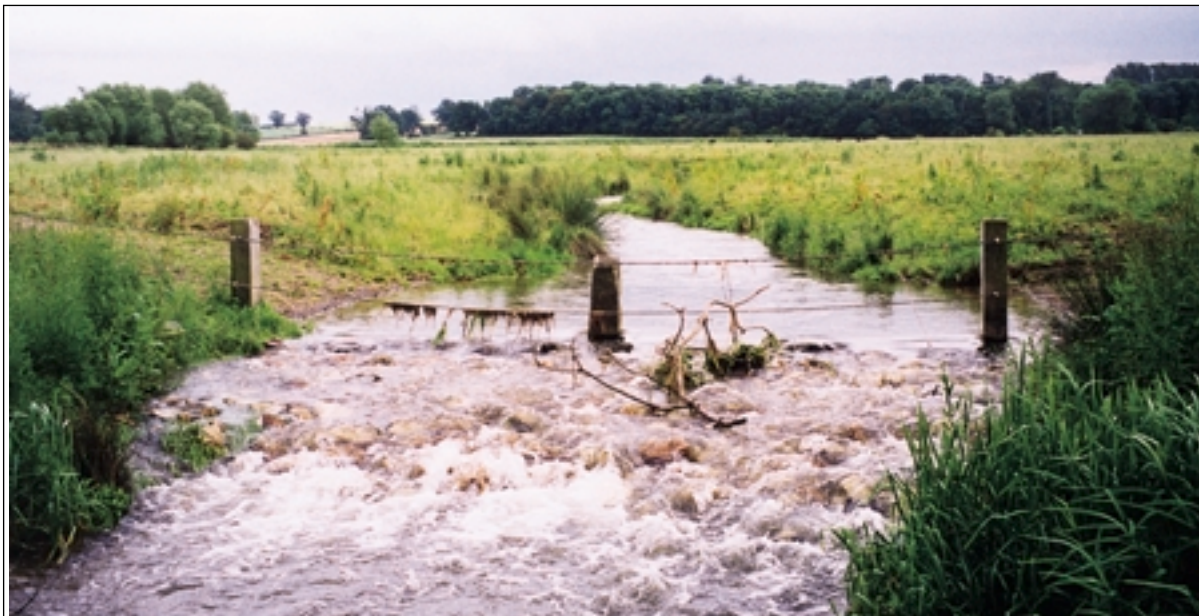
Weir and rock apron

The upper confluence structure has lost stone from the weir because the size used was below the 300mm graded mix specified. The structure remains functional because the block wall is stable - numerous larger stones have settled out below it. The stone work was re-built in summer 1998.

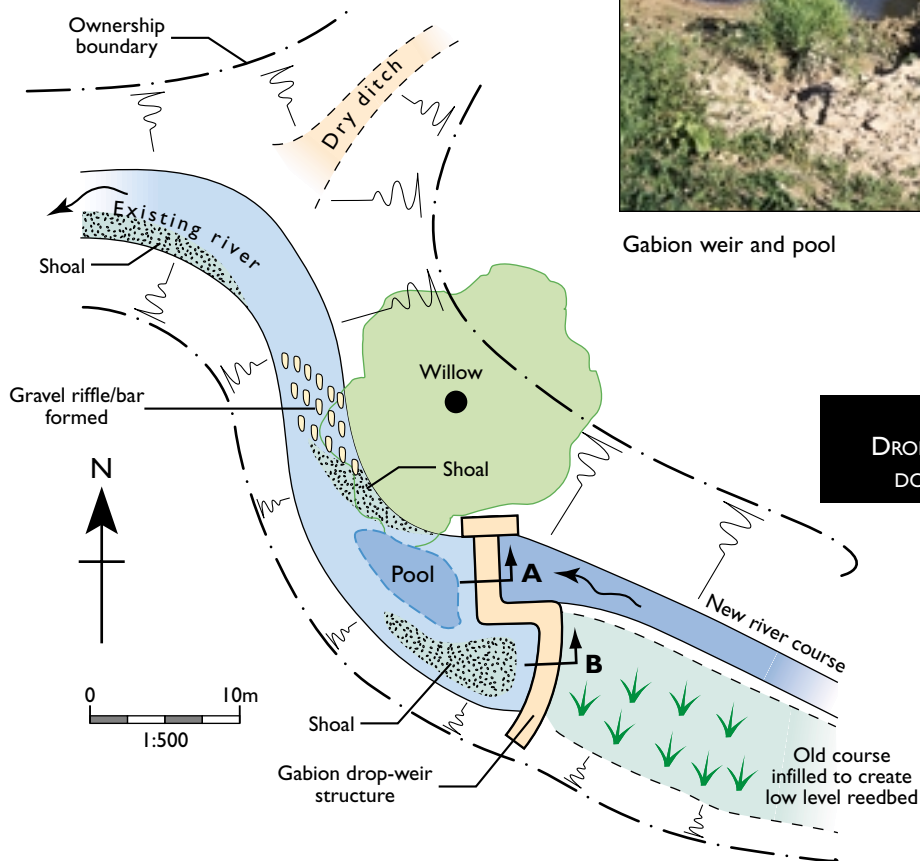
Gabion weir and pool

The lower confluence has been an outstanding success and the change in normal water levels at the structure is now barely discernable, but is marked by a change from fast flowing water in the new channel to a deep, still pool of water that precedes the riffle. The gabion structure is virtually hidden from view among the vegetation that has grown up within it.
