# PROVIDING PUBLIC, PRIVATE AND LIVESTOCK ACCESS

## 8.4 Restoring a ford as a stock and vehicular crossing point

### RIVER OGWEN

LOCATION – 5km south of Bethesda, Gwynedd SH 641615

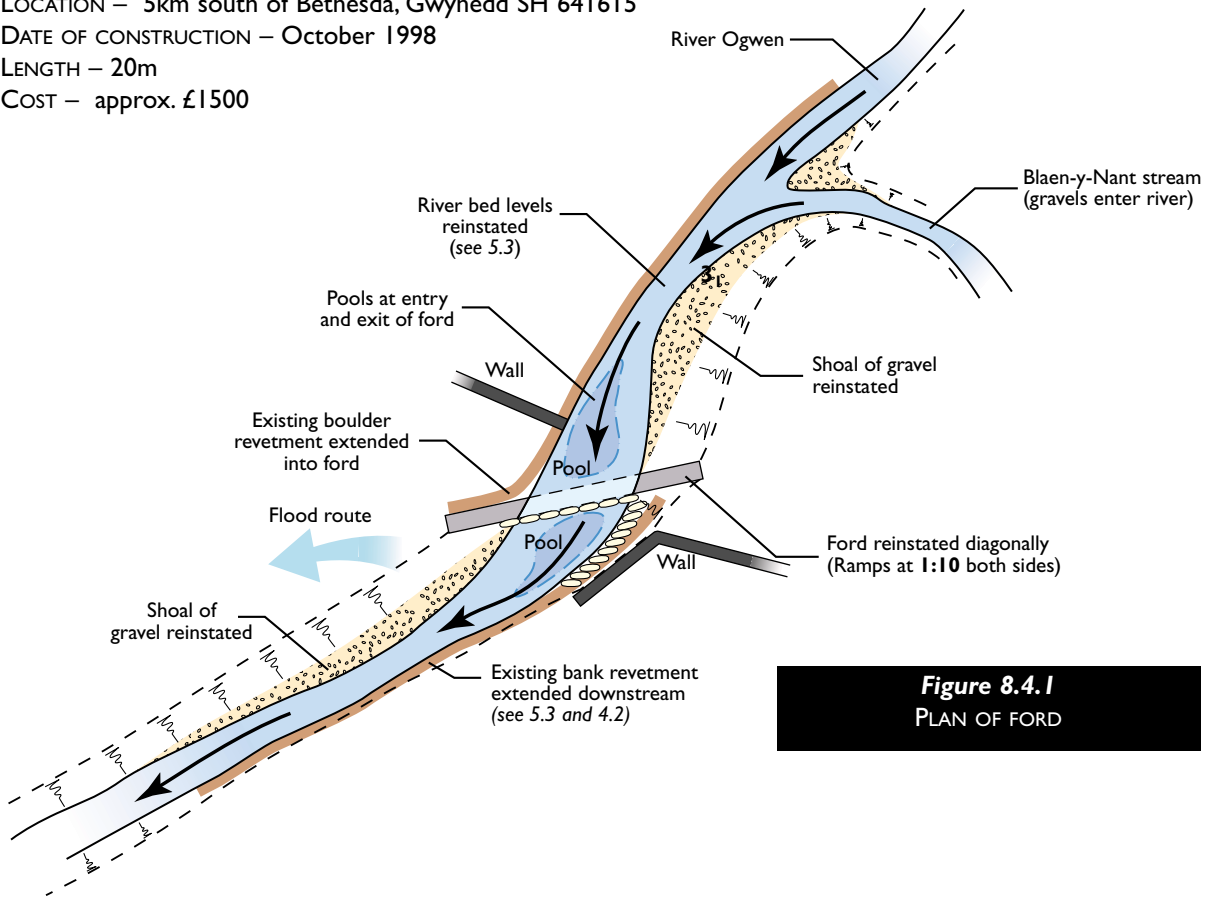
**Figure 8.4.1**  
PLAN OF FORD

The location of two solid stone walls on opposite banks of the river were a further consideration. The routing of overland floodwaters down the valley would clearly be interrupted by these opposing walls with all flow being concentrated between them coincident with the location of the ford (*see plan*).

Careful study of the topography of the adjoining fields indicated that the natural flood route involved overtopping the bank on the right side of the ford (looking downstream). This bank was carefully graded to blend with a discernible ‘gully’ down the field such that floodwater passing between the two walls could easily escape out onto the natural floodway again without causing undue stress at the ford. The arrow on the plan indicates this important floodway.

profiles upstream and downstream of the ford. The river bed was also fully restored with gravel upstream and downstream of the ford with particular attention to the profiling of pools and runs that naturally form at opposing bends (*see plan*).

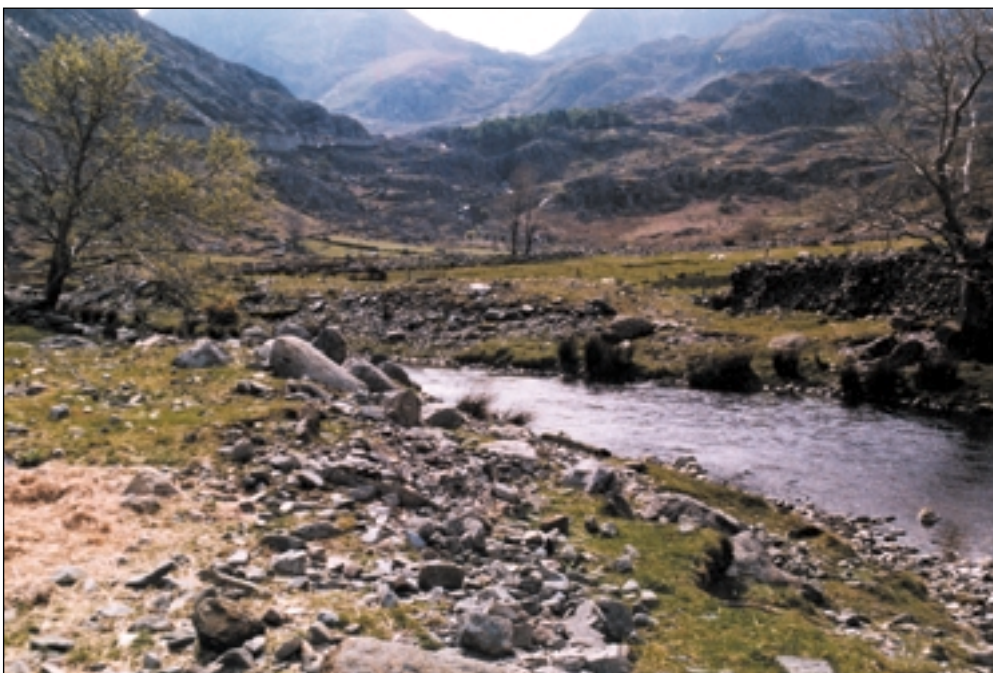
View across the deepened river at the old ford location

Old O.S maps indicated a ford had existed prior to dredging but it had been removed during these works; see photo of conditions pre-restoration. The farmer was keen for the ford to be restored as a stock and vehicular crossing point.

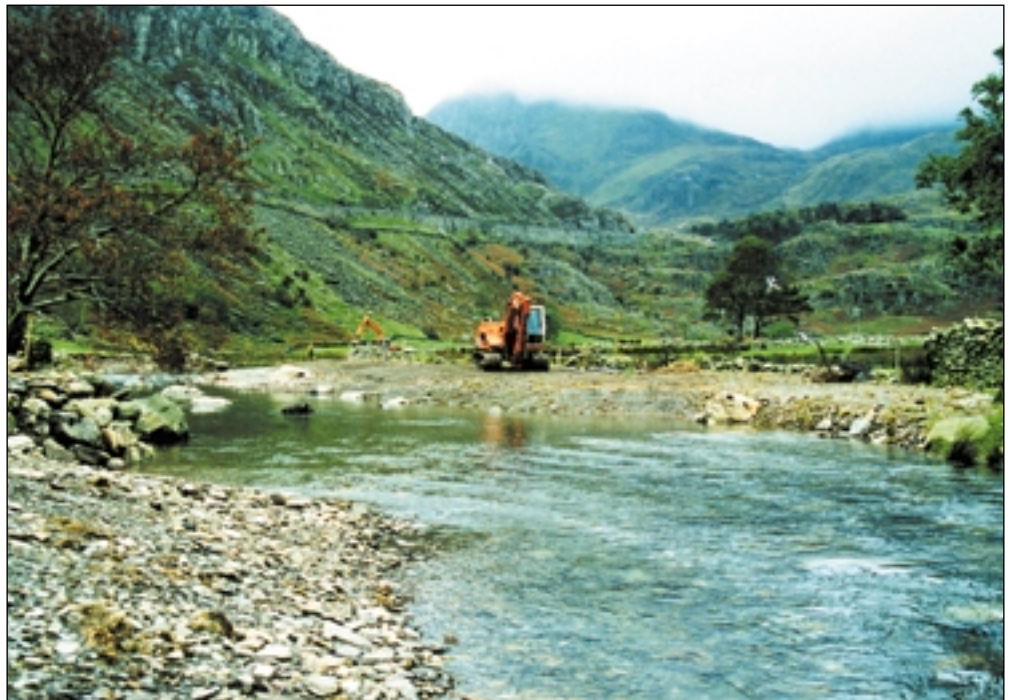
The restored ford, shoals and riverbed

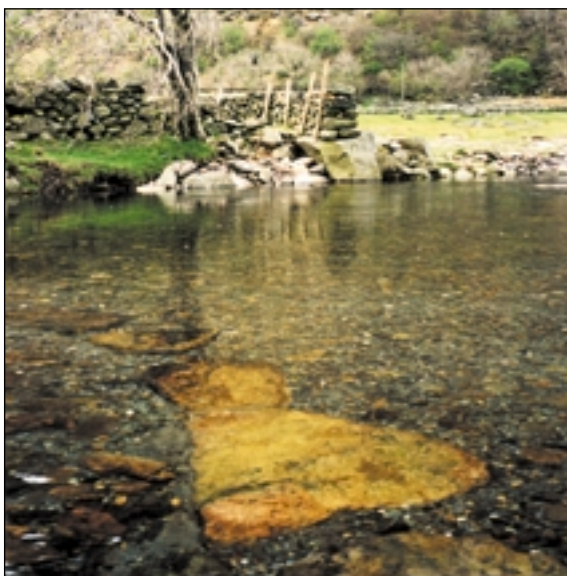
Downstream crest defined by boulders

The entire configuration of the ford, shoals, pools and runs has proved to be sustainable, with the ford in regular use by the farmer.
