ENHANCING OUTFALLS TO RIVERS

9.1 Surface water outfalls

RIVER SKERNE

LOCATION – Darlington, Co Durham, NZ 301160

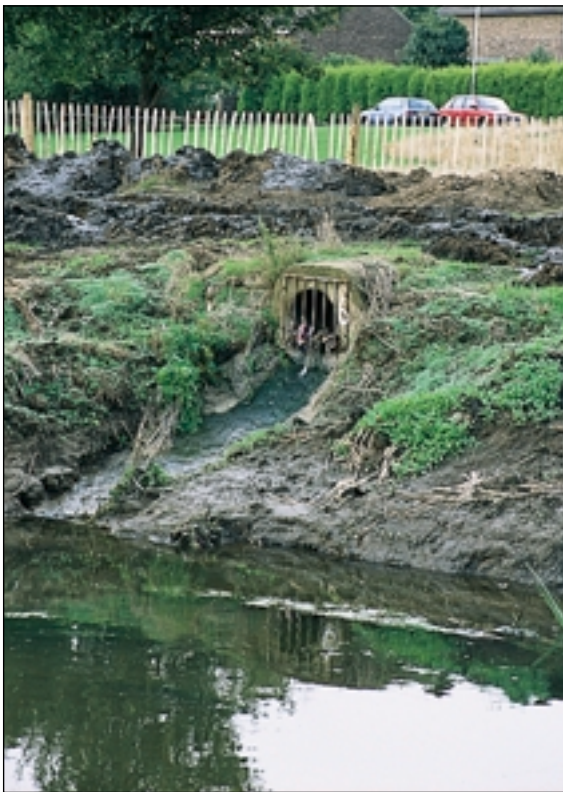
Typical outfall before replacement

Although the water quality of the Skerne has been steadily improving, public perception of the river was one of a polluted watercourse. Along the core reach of the river restoration project there were 13 public surface water outfalls with ugly concrete headwalls marking their points of discharge. Those with grills were cluttered with plastic and other litter. The project provided a unique opportunity to instigate further improvements to water quality and visual amenity.

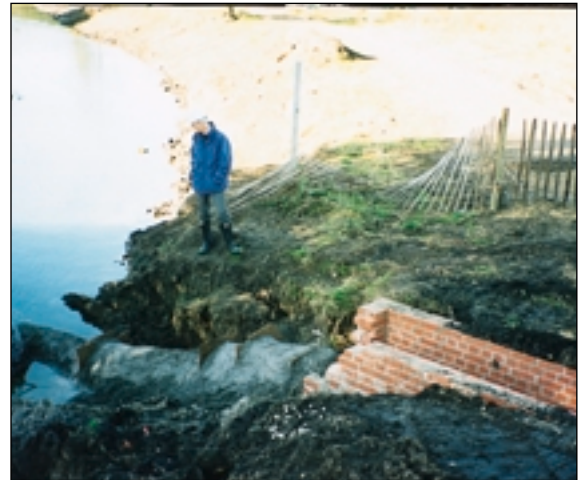
New outfall chamber under construction

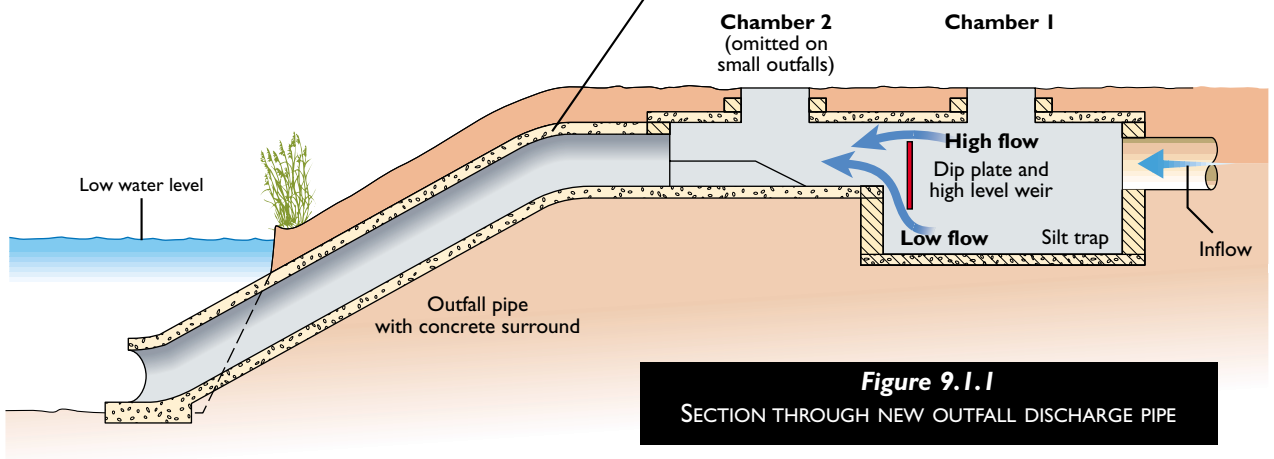
Figure 9.1.1
SECTION THROUGH NEW OUTFALL DISCHARGE PIPE

Angled to discharge below low water level, the outfall pipe lies on a concrete apron which reduces scour during high flows. The outlet is turned to face downstream so that the river draws the discharge. Additionally, an underwater gabion was installed upstream of the outlet to reduce the risk of pipe damage by floating tree branches, etc. Direct jetting via the chamber is possible if outlets become silted but they are expected to be self cleansing. The velocity of discharge achievable has been seen to make the river 'boil' after heavy rain.

NOTE: River bank reinstated with soil and toe planting such that no visual evidence of the outfall exists
