# RESTORING MEANDERS TO STRAIGHTENED RIVERS

## 1.5 New meandering channel replacing concrete weirs

### RIVER MARDEN

LOCATION - Town centre at Calne, Wiltshire ST 998710

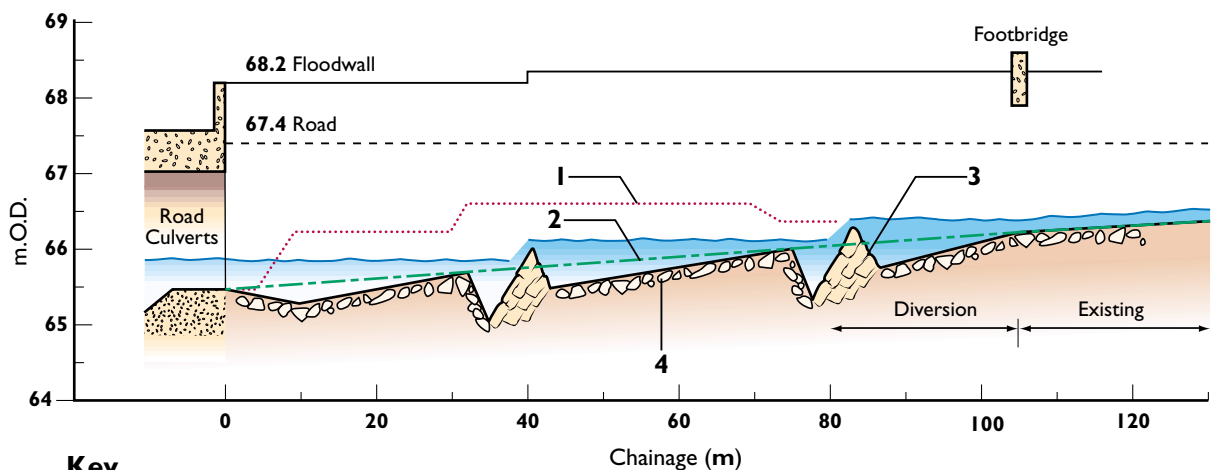
**Figure 1.5.2**  
LONGITUDINAL PROFILE

The gradient of the new river bed became 'fixed' between the culvert invert and the existing upstream level. Figure 1.5.2 shows the resultant longitudinal profile with a mean bed gradient of 1 in 140. This gradient is much steeper than arises naturally on this part of the river with consequent high water velocities when the river is in flood.

- 1 Original bed level – concrete channel with two drop weirs
- 2 New mean bed gradient at 1 in 140
- 3 2 stone riffles built to stabilise river bed; pools upstream and downstream of each
- 4 Actual bed profile of gravel and cobble substrates

The steepness of the river bed gradient needed to be checked by introducing two low barriers of rock to resist any tendency of the bed to scour downwards. These are shown as feature 3 on figure 1.5.2. They are located just downstream of each meander bend where underwater bars of river bed substrate e.g. gravels would naturally accumulate in the form of riffles. The stonework on adjacent walls and river

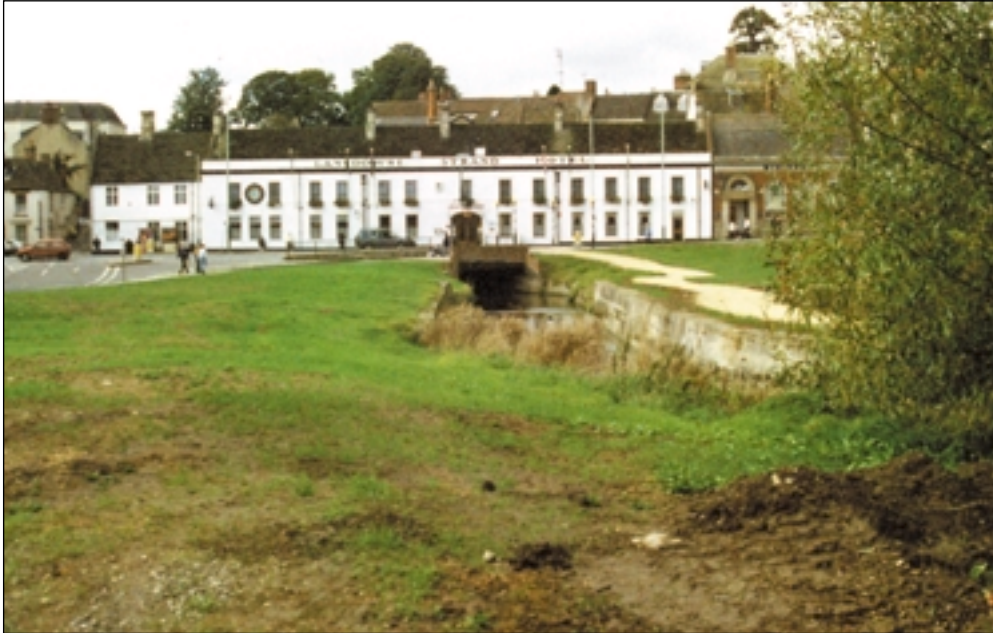
Before:  
View downstream  
towards culvert

A town centre factory had been demolished leaving a reach of river flowing through the site in a straight, concrete channel. The channel bed dropped vertically in two places forming weirs that barred the passage of fish and were unsightly.

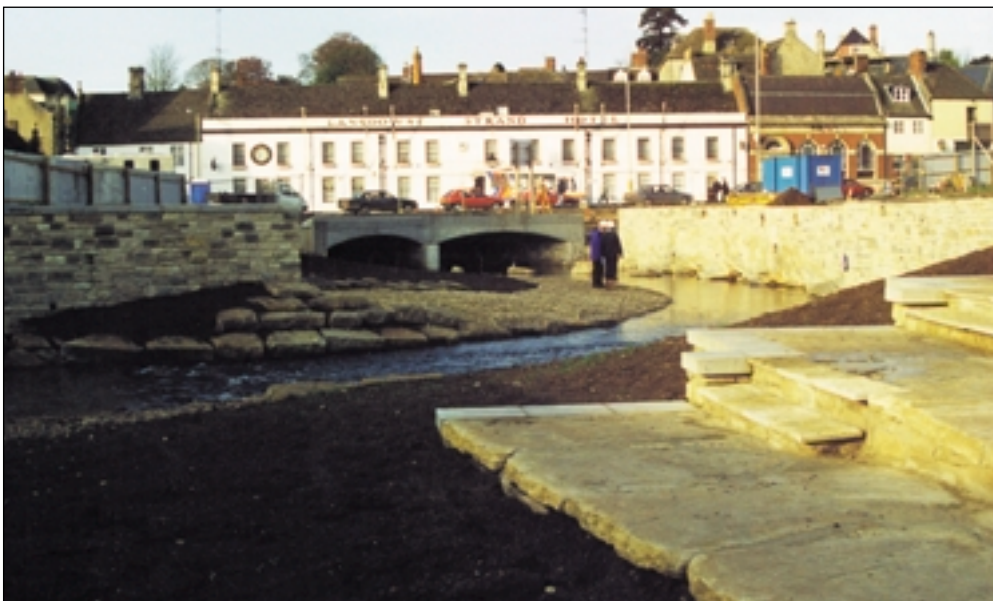
Completion:  
View of the new  
river course

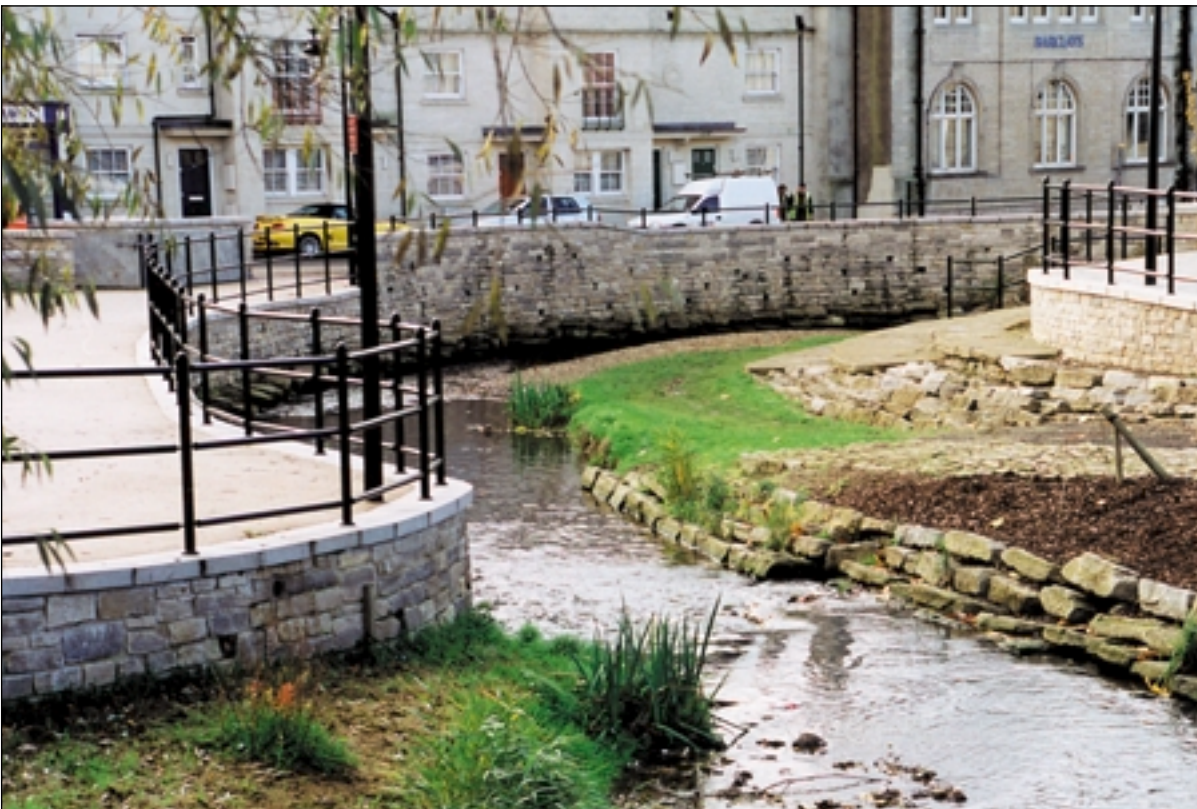
View of Section A in November 2001
