# RESTORING MEANDERS TO STRAIGHTENED RIVERS

## 1.6 Opening up a culverted stream

### RIVER RAVENSBOURNE

LOCATION - Norman Park, Bromley TQ 412674

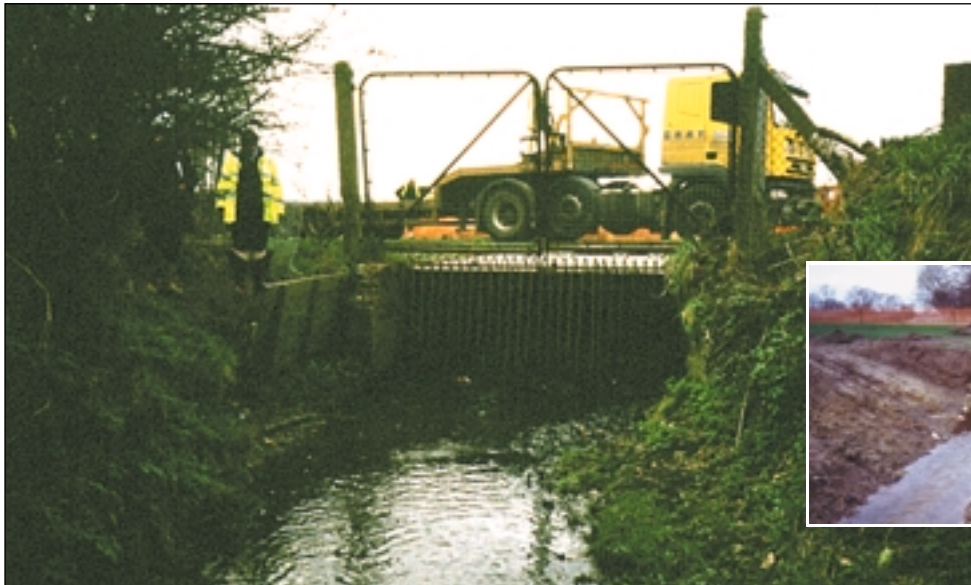
View of headscreen prior to removal

Financial justification for the scheme was threefold: reduction in costly maintenance for a culvert, the removal of a trash screen that also required regular clearing and was a health and safety issue, and an increase in flood storage. There was also a positive environmental gain.

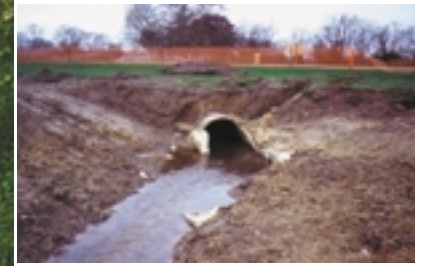
'Daylighting' of the Ravensbourne

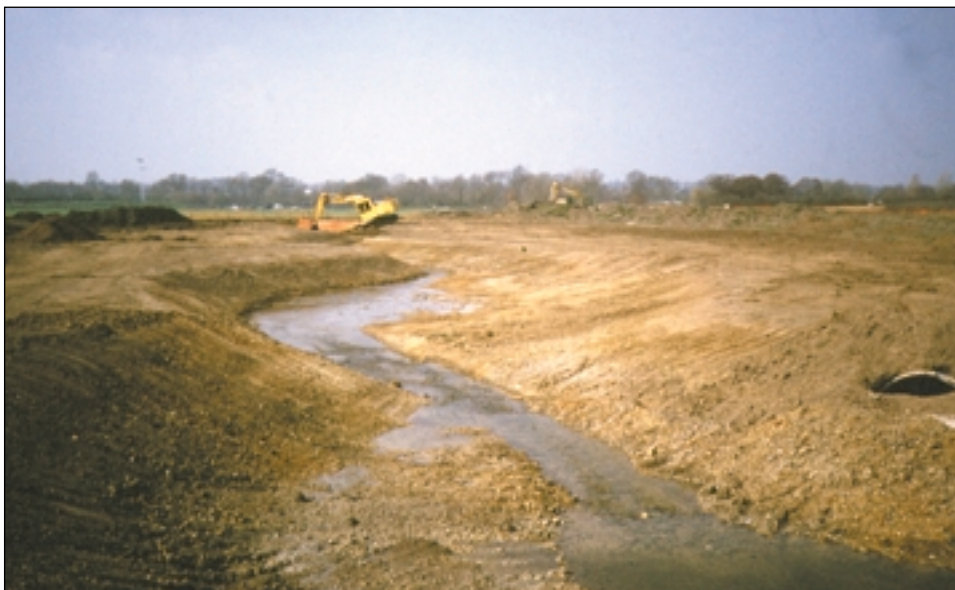
Looking downstream at the shallow bank slopes. The severed culvert still visible

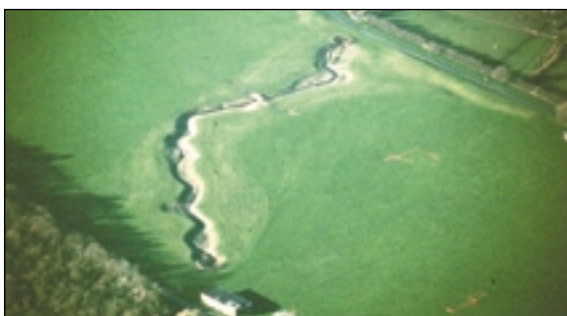
The new sinuous course and extent of wildflower seeding

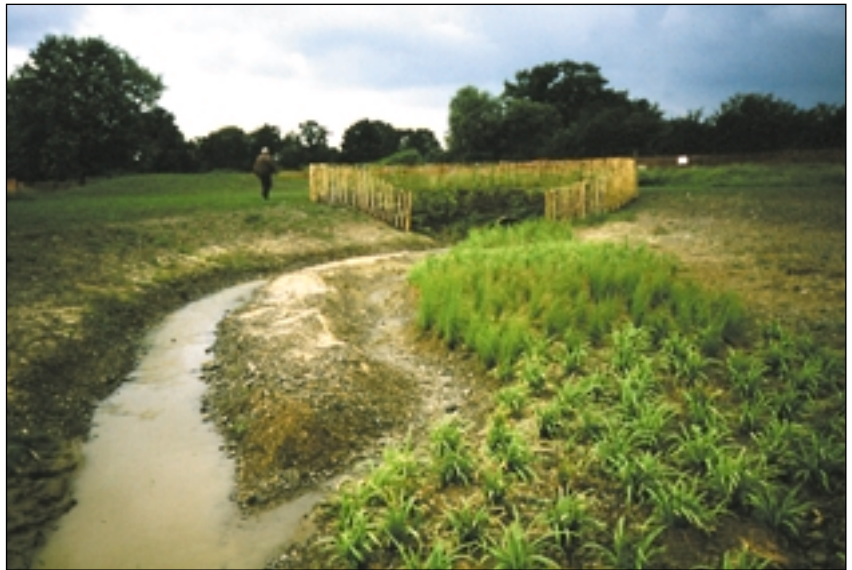
Planting up the 'wet berm' area and shielding the culvert entrance with shrub planting

Topsoil was not replaced on the riverbanks in order to attain a low fertility substrate suitable for the natural colonisation of wildflowers and plants from upstream. A 'buffer zone' between the amenity grassland and the top of the bank was seeded with a low-density wildflower mix from an approved source. This creates a visually pleasing edge to the playing fields and provides a suitable seed source for the banks. On the river's edge native provenance marginal plants were specified from a carefully sourced local nursery. School children were involved in some of the marginal planting. Wildflower plugs were also planted. The culvert entry and exit were both screened using a variety of native shrub species.
