Working to restore & enhance our rivers

ENHANCING STRAIGHTENED RIVER CHANNELS

3.2 Narrowing with aquatic ledges

A) RIVER SKERNE

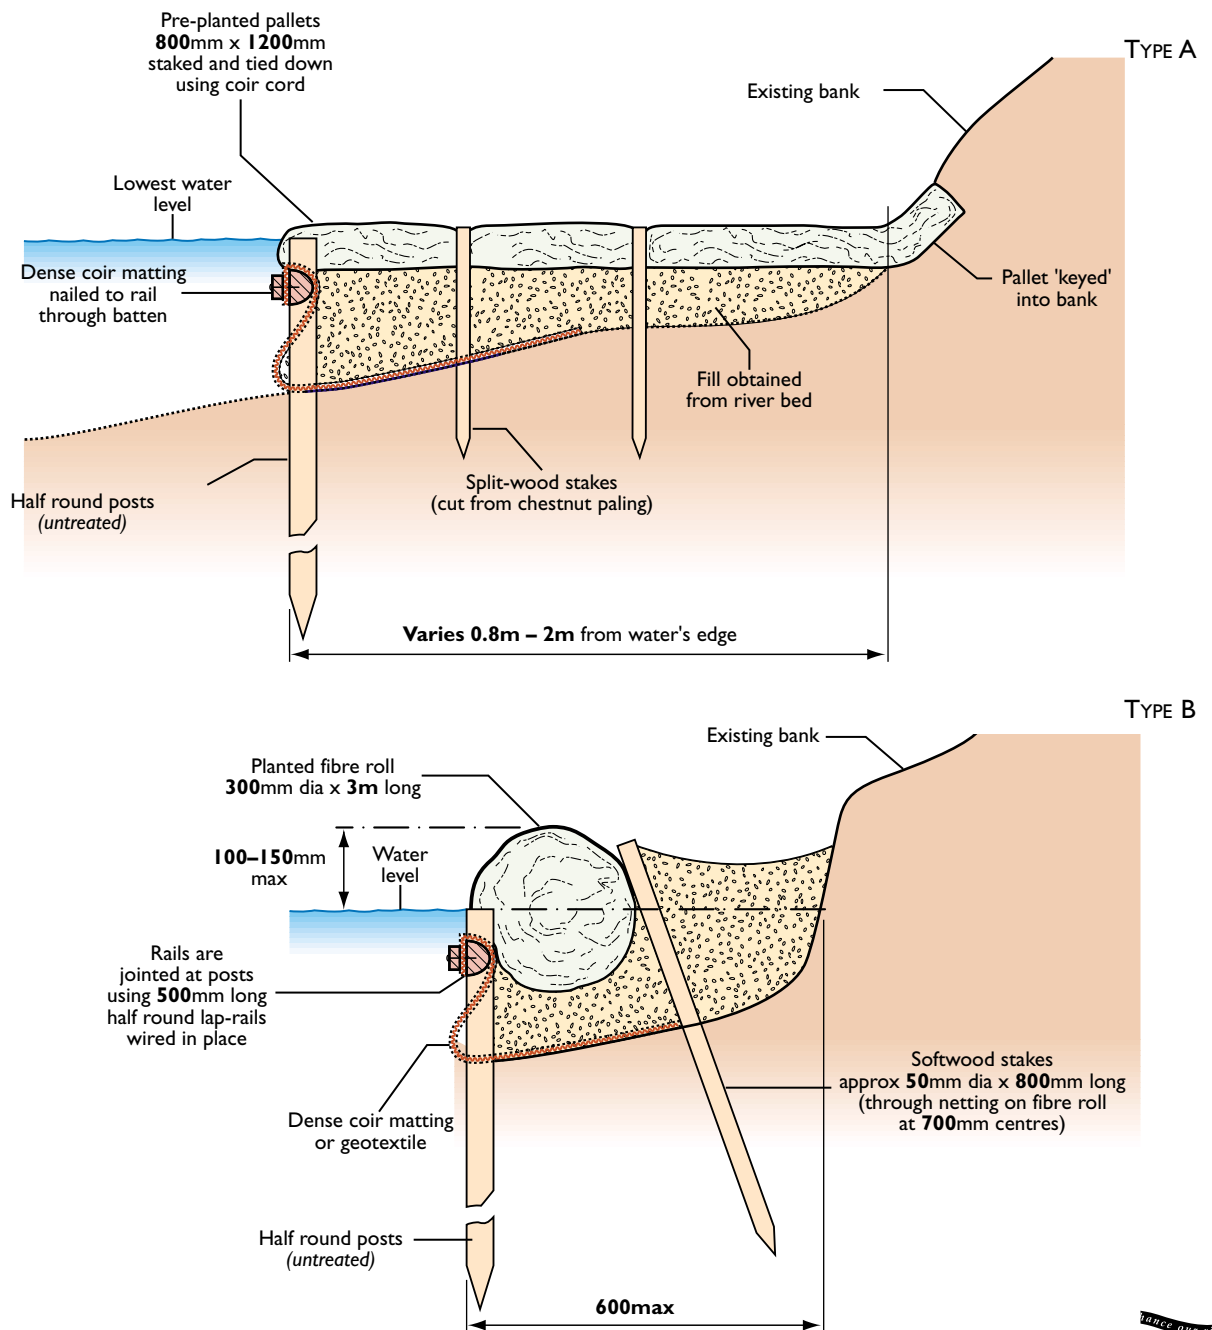
Figure 3.2.1
SECTIONS THROUGH TYPE A AND TYPE B LEDGE DESIGNS

Two designs were developed utilising proprietary matting to hold backfilled river silts in place along the waterside (*fig. 3.2.1*). The ledges created were either planted with pre-grown materials or left to colonise from planting introduced nearby.

Type A design is suited to wide ledges (up to 2m at this site) but the width can be varied to introduce curvature to the plan alignment.

Type B design is suited to narrow ledges and is most appropriate where the river bed falls away steeply at waters edge and a small fringe of marginal vegetation is all that can reasonably be sustained.

Both designs rely upon a face of untreated timber posts and rails to hold the matting containing silt backfill. To ease construction, these are firstly assembled with matting in place just above water level and then the posts are pushed below water using an excavator bucket. The use of wire ties at rail joints affords the necessary flexibility.

Biodegradable coir matting was favoured, but some nylon matting (Enkamat) was utilised in the type B application where hydraulic conditions suggested a long life material was needed. Under most conditions the root growth of the plants introduced is expected to consolidate the underlying silts whilst matting and timber slowly decay, perhaps over a 5-10 year period. Emergent growth was expected to attract silt deposits as plants become established.

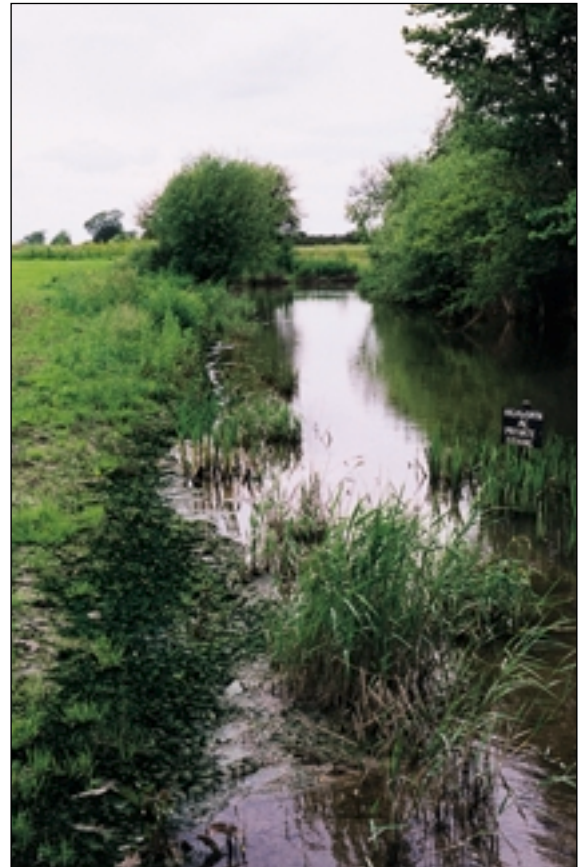
The ledges overwintered well in dormant conditions with no structural damage by floods although little more than 50% of the plants appeared to have survived to grow on during summer. The ledges are developing very well (1998) and creating both emergent vegetation habitat and landscape enhancement in the short stretch of river that previously had the least habitat and visual amenity value.

Type A and B ledges on the Cole after one winter

Post and rail was driven up to 2m out of from the waters edge, coir matting attached and then backfilled with soil excavated from the same river bank. Excavation from the river bank enabled the width of the ledge to be extended, to more than 2m in places but, more importantly, it afforded a flatter, more varied bank profile than the previous 1:1 batter. Transitions into the existing banks at each end used the type B design.

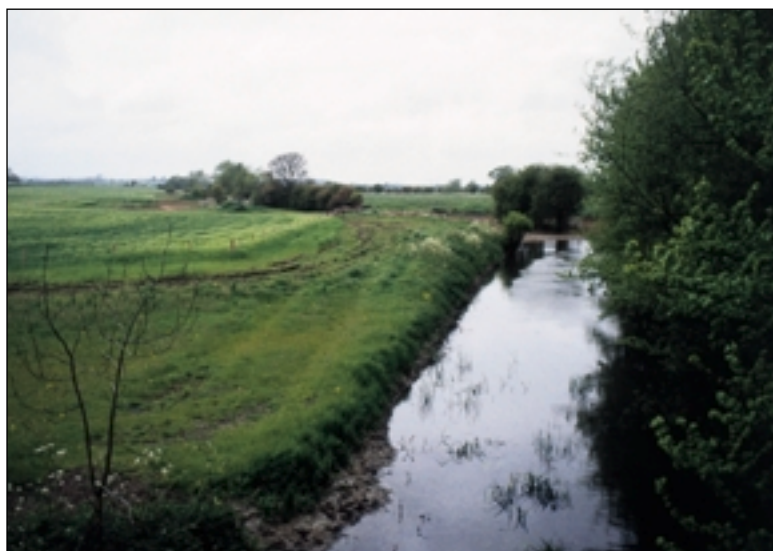
Prior to re-profiling and ledge construction – May 1996
