REVETTING AND SUPPORTING RIVER BANKS

4.4 Plant roll revetment

RIVER SKERNE

LOCATION – Darlington, Co Durham, NZ 301160

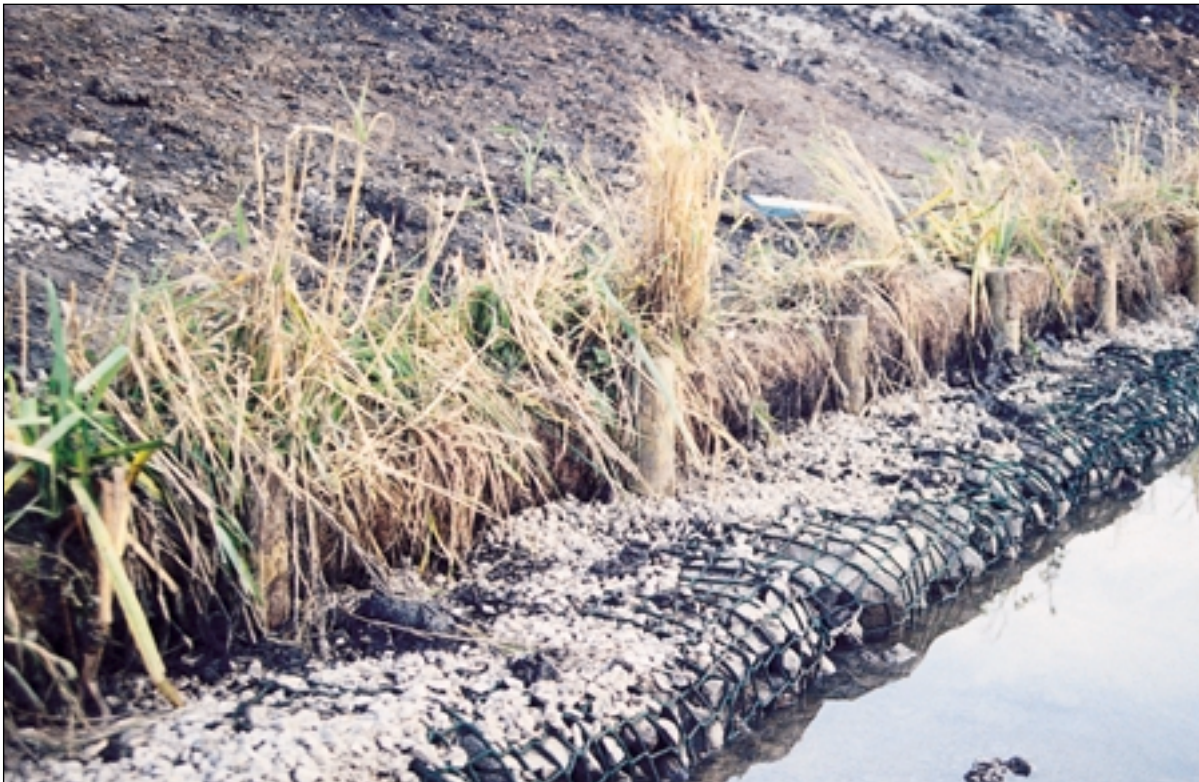
Transitional revetment at installation (water level artificially low in photo)

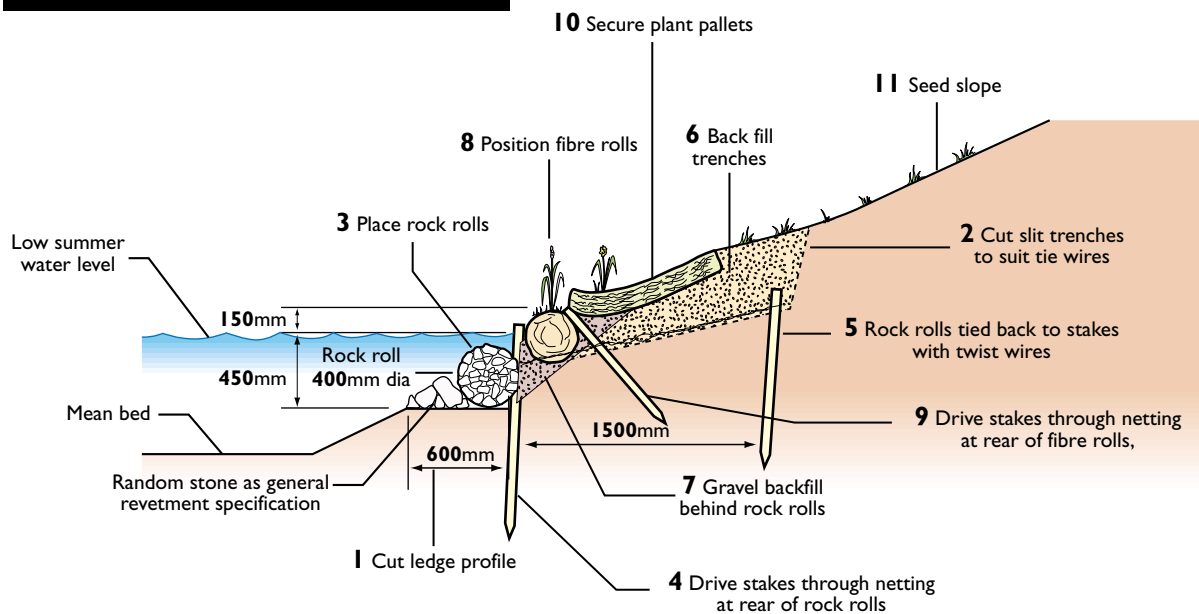
Figure 4.4.1
PROFILE OF TRANSITIONAL REVETMENT

Rock rolls are flexible 'sausages' of crushed rock contained within nylon netting, whereas plant rolls are of dense coir within which selected marginal aquatic species can be pre-grown. Plant rolls fixed over rock rolls will become homogeneous as roots penetrate downwards into the rock and the adjacent soil. The design provides inbuilt flexibility

Rock rolls are set out below water on ledges cut to suit and secured by driving posts through the netting. Long term stability and flexibility is achieved by pulling the rolls tight against the posts using twist wires anchored to stakes set well back.

Plant rolls are set out at low water level and wedged tight up against the rock rolls by driving stakes at a suitable angle along the rear of these.

Pre-planted flat pallets of coir were added above the plant rolls to increase the extent of marginal vegetation although this is largely an aesthetic measure.
