REVETTING AND SUPPORTING RIVER BANKS

4.7 Bank revetment using low steel sheet piling and coir rolls

RIVER THAMES

LOCATION - Clifton Lock Cut, Oxfordshire SU 544944

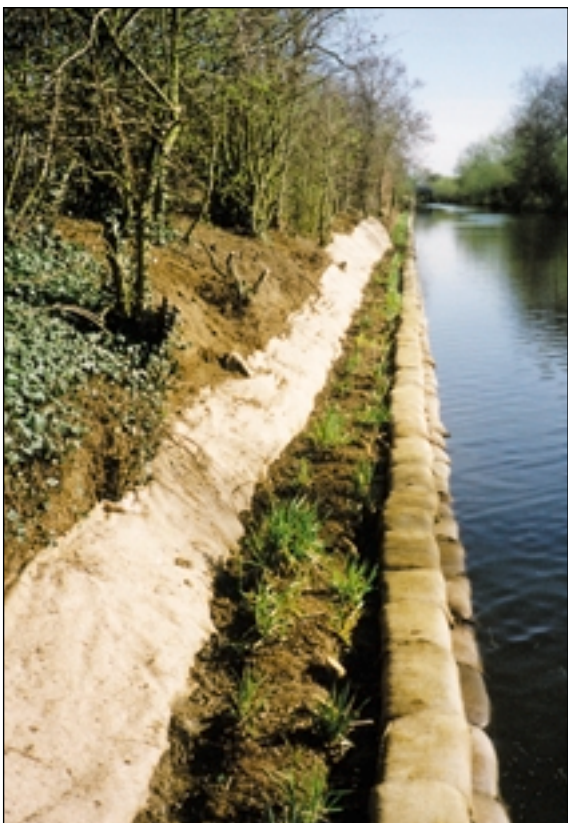
Flax mat secured, planted coir rolls installed and voids backfilled

The upper slope was formed from imported topsoil and covered with a biodegradable fibre mat to protect and retain the sloping surface. The mat was used along most of the reach, a necessity due to the timing of the works with little opportunity of vegetation establishment before high winter flows. The matting was pinned to the slope using wooden pegs, rising to the retained shrubline. The bank was not seeded to allow natural re-vegetation.
