# CONTROLLING RIVER BED LEVELS, WATER LEVELS AND FLOWS

## 5.1 Bifurcation weir and sidespill

### RIVER COLE

LOCATION – Coleshill, Oxon/Wilts border, SU 234935

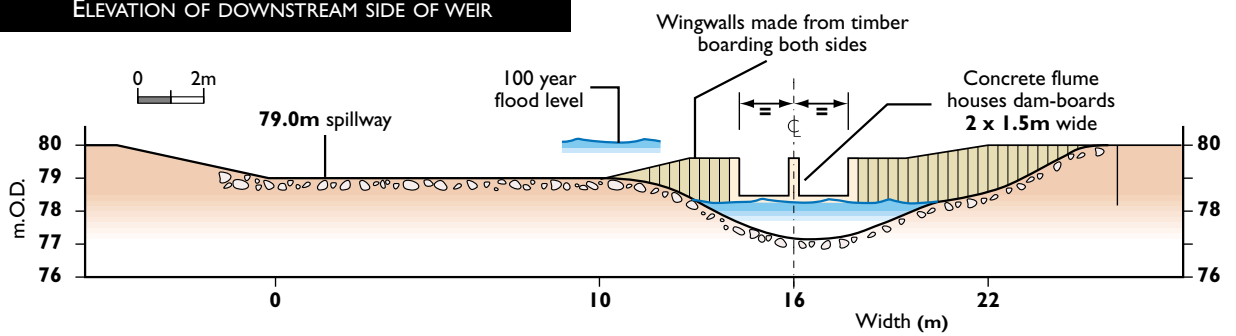
**Figure 5.1.2**  
ELEVATION OF DOWNSTREAM SIDE OF WEIR

Control weir (location ① on plan)

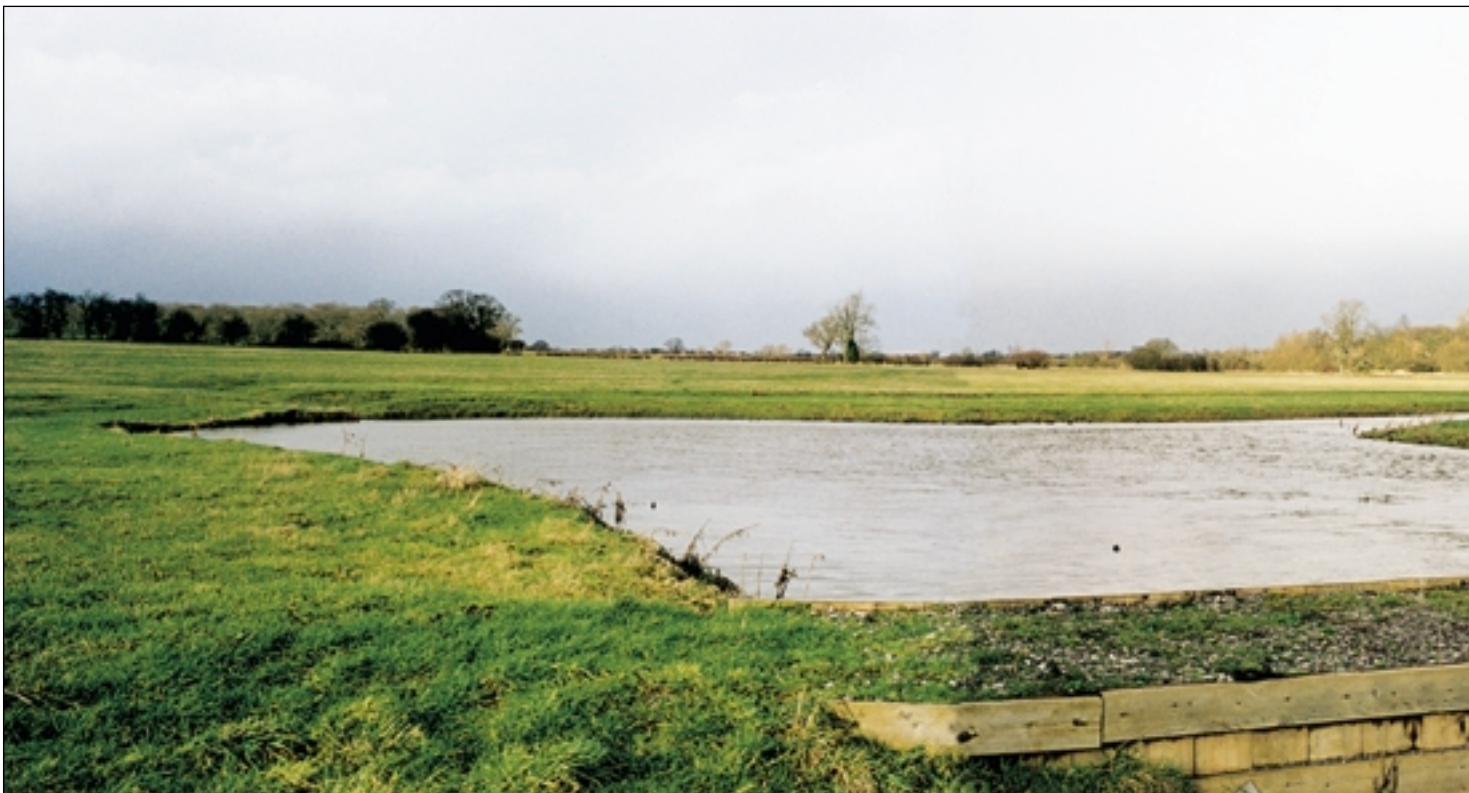
The structure has functioned exceptionally well and fulfils all design criteria. The complex configuration of channel and landforms combine with diverse patterns of flow currents to sustain a variety of habitat niches as well as an overall feature of landscape interest. Snipe are commonly seen probing the marshy areas intrinsic to the design. The National Trust (owners) plan to undertake landscape planting, and to provide a permanent bridge to further enhance the location. The abundance of fish in the new channel suggest that migration is occurring satisfactorily.

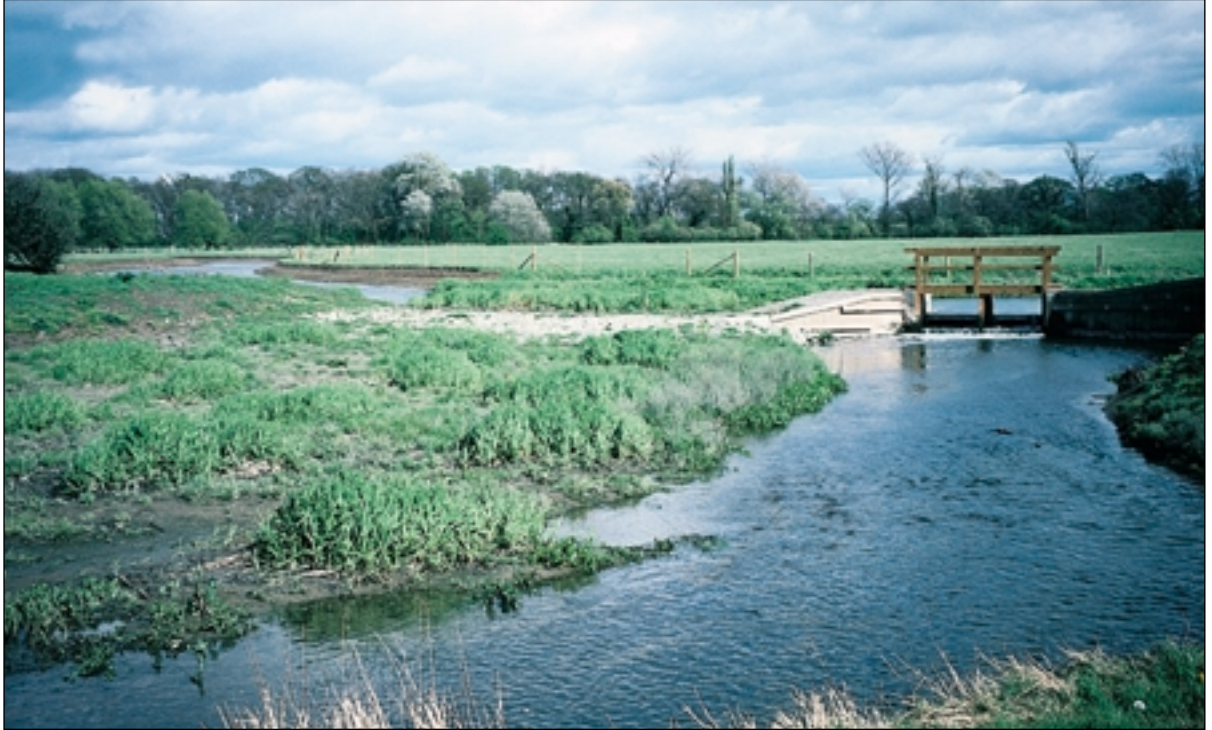
Spillway alongside bifurcation weir  
– April 1997

The hydraulic capacity of the flume is small (to suit base flows) so a 10m wide spillway is incorporated alongside to feed sufficient floodwater to fill the new channel. The crest level is only 0.1m above the normal water level in the leat so it operates frequently. Below the spillway, a large area of land is gently graded out towards the new channel which sustains marshy conditions around its inner margins. This low lying area is largely flooded before overspill occurs, ensuring a fairly smooth combining of floodwaters passing downstream. Water in the new channel rises quickly, ensuring the overspill is completely submerged (drowned) at an early stage of a rising flood, thereby further reducing scour potential.

The spillway is defined by two parallel lines of road kerbs infilled with stone/gravel (a small amount of rock is incorporated along the downstream edge of the kerb line where eroding eddy currents are strongest). Reeds growing upstream of the structure also help to ensure stability and improve 'natural' blending between hard and soft elements.
