## ENHANCING STRAIGHTENED RIVER CHANNELS

**3.3** Stone riffle

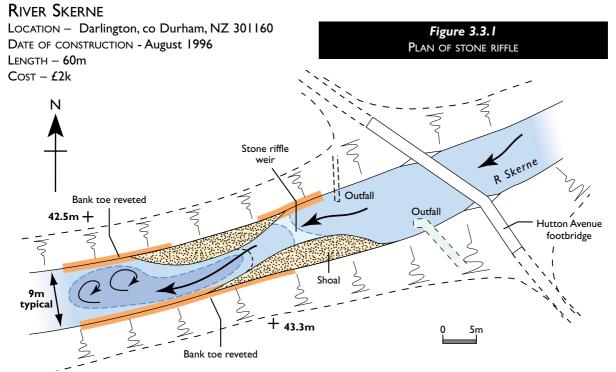
Stone Riffle downstream of Hutton Avenue footbridge

The Skerne has no natural gravel sediments in the restoration reach, so the introduction of a stone riffle feature needed to be entirely artificial and self sustaining. A riffle located just downstream of Hutton Avenue footbridge afforded several benefits within what was a featureless, straight reach of river (*see 3.1 and 3.2 for other enhancements in the same reach*).

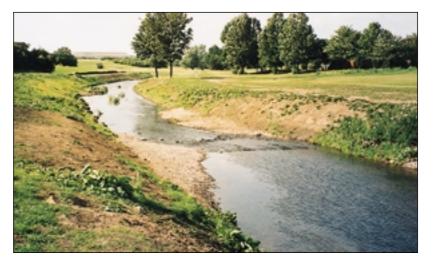
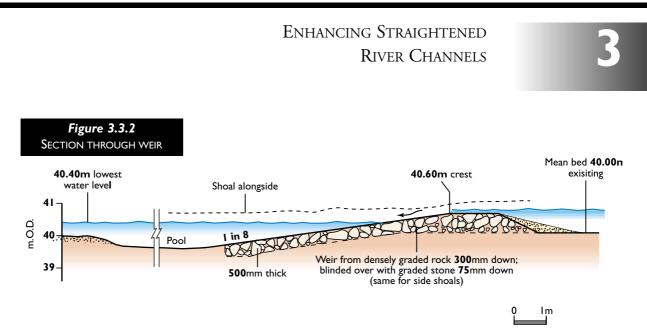
The riffle is configured as two semi-eliptical shoals, diagonally opposite each other, that are linked by a shallow sloping weir, such that the whole is a single, homogeneous structure. During low flows, only the weir is submerged but the shoals quickly drown as flows increase. The configuration sustains a deep,

faster flow of water around the downstream shoal that noticeably eddies as the currents merge with the lower river. These variations in the speed, depth and direction of flow all sustain habitat diversity. The river banks alongside each shoal are graded as flat as practical to make access to the water's edge easy and safe. The toes of the river banks are reveted with stone where river flows are accelerated during passage over the structure and beyond.

Although described as a riffle, the structure was designed as a low weir. Scour of the structure, as well as the river bed and banks downstream, were primary considerations.

The stone used for construction was a densely graded crushed rock mixture sized 300mm down to 5mm. The dominant size (at least 50%) was in the range 125-300mm to ensure that the structure would not wash away during floods, albeit some adjustment to form would inevitably occur. As a final measure, the entire structure was covered in a layer of smaller crushed stone to simulate gravel. This mixture was

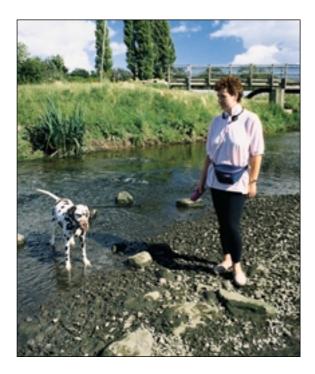
The riffle allows easy access down to the river - November 1996

Of particular note is the popularity of this spot with children who can gain safe access to the river and paddle in the shallow water, where the bed is firm and stoney.
