# ENHANCING OUTFALLS TO RIVERS

## 9.2 Reedbed at Raglan Stream

RIVER COLE

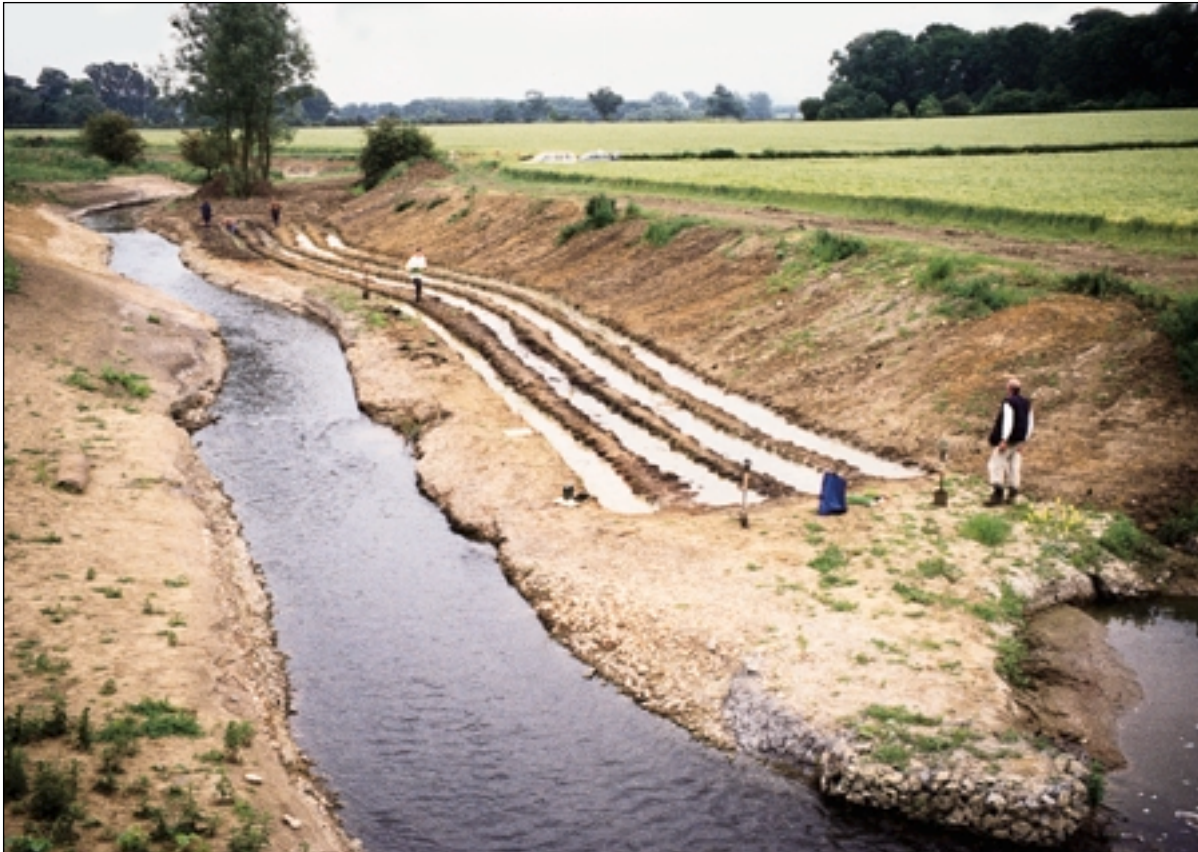
Planting reedbed – Spring 1996
