MANAGING OVERLAND FLOODWATERS

6.3 Removing and setting back floodbanks

LONG EAU

LOCATION - Manby, Lincolnshire TF 407863

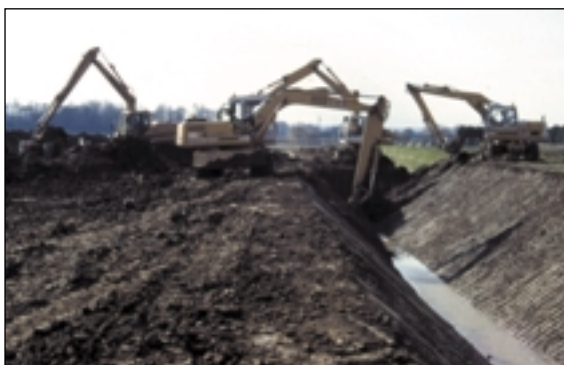
Relocating the IDB drain and set-back floodbank

The 2100m³ of spoil from the bank removal was used to fill in an Internal Drainage Board drain that ran through the centre of the proposed storage area. This had to be re-routed behind the new ‘set-back’ floodbank to maintain the integrity of the upland and lowland drainage system. Material excavated from the construction of the new drain was used to form the new floodbank, set back from the river by up to 300m. The new bank is large due to the volume of material that needed to be excavated to re-route the IDB drain. The new embankment is constructed of clay with slopes of 3:1 to a height of 2.5m to 2.7m above the adjacent ground level. This gives a designed crest level of 4.5m above OD with a crest width of 3.5m minimum. The volume of material used for the embankment was 18,500m³.
